TECHNICAL BULLETIN
UPS4812-6bNAS2
31 MAY 2013

Update Prior to Sale: Front Sub Frame Bolts Incorrectly Torqued

XF (X250)
Model Year: 2012-2013
VIN: S60251-S62610

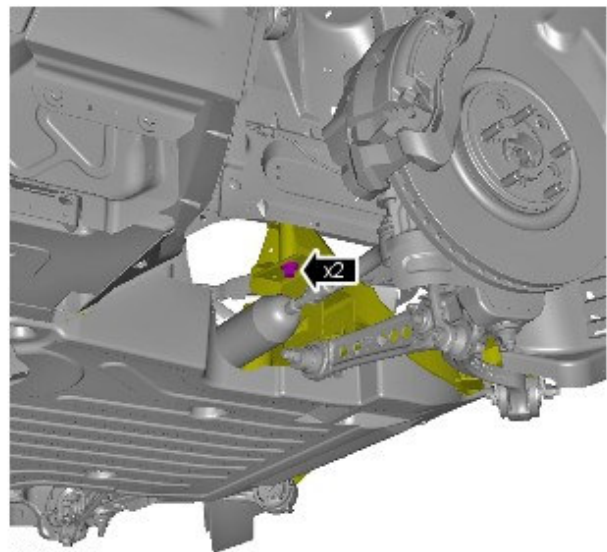
E150119

Situation: A concern has been identified with a limited number of 2012 model year XF vehicles where the front subframe rear bolts have the incorrect torque applied.

Remove and discard the front subframe right-rear bolt.

3. Install a new front subframe right-rear bolt.
 - Tighten the new bolt to 80Nm + 240°
4. Remove and discard the front subframe left-rear bolt.
5. Install a new front subframe left-rear bolt.
 - Tighten the new bolt to 80Nm + 240°
