## Field campaign

E782

Transaction No.: 2033405/2

New Continental GT and GTC - V8T Engine control module update  
(SC13/06)

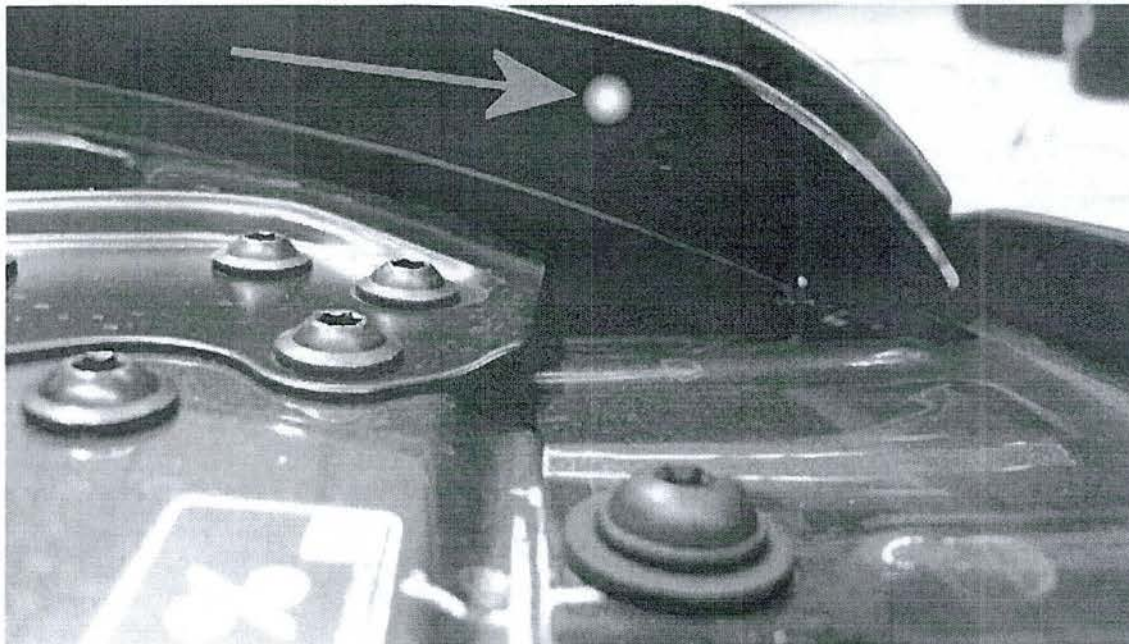
White paint completion mark on the right hand radiator shell fixing (see Figure 17)

7. Place a White paint confirmation mark on the right hand radiator shell fixing as shown in Figure 17
