SB-10052615-8081

SI B01 02 12
Warranties

NEW N54 Engine Turbocharger Wastegate: Emissions Warranty Extension to 8 Years/82,000 Miles

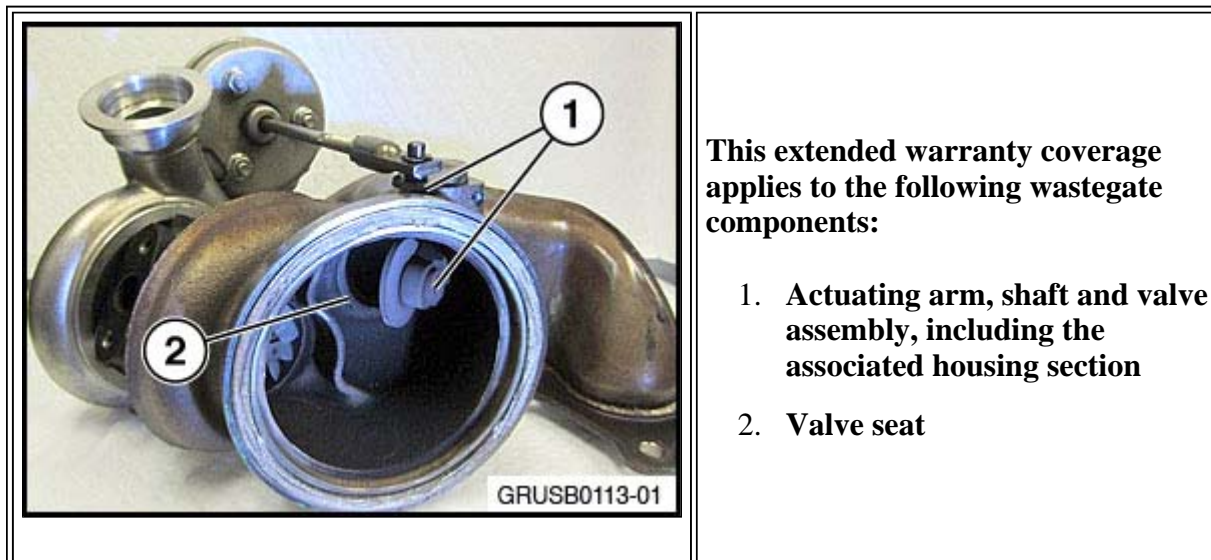
This extended warranty coverage applies to the following wastegate components:

1. **Actuating arm, shaft and valve assembly, including the associated housing section**
2. **Valve seat**
