SB-10052632-1074

Title: Bus Heater Booster Pump Running Backwards due to reversed power polarity

Applies To: All CE, RE and FE buses with Heater Booster Pump Retired Documents: IK2200076

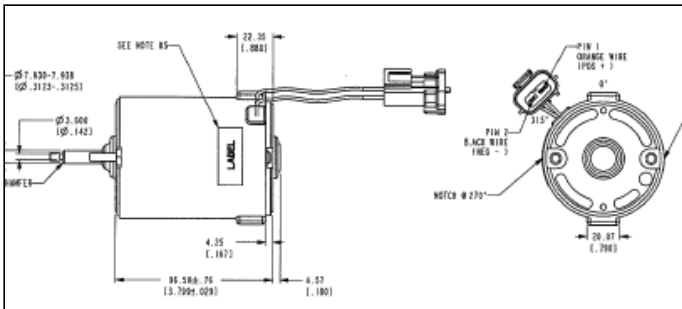
When replacing the booster pump with one of the part numbers below, verify that the wiring of the new pump to the bus harness is correct. Reversed polarity of the power and ground circuits to the pump will cause the pump to operate backwards.

Failure to wire the pump correctly will result in failure of the pump.

The correct wiring is as follows:

POSITIVE: Orange lead from booster pump to blue lead on bus harness.

GROUND: Black lead from booster pump to the white lead on bus harness.
