**SB-10052632-4512**

**Title:** Bus Heater Booster Pump Running Backwards due to reversed power polarity

**Applies To:** All CE, RE and FE buses with Heater Booster Pump Retired Documents: IK2200076

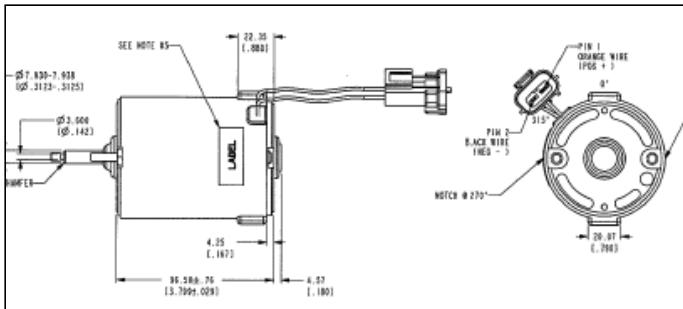
When replacing the booster pump with one of the part numbers below, verify that the wiring of the new pump to the bus harness is correct. Reversed polarity of the power and ground circuits to the pump will cause the pump to operate backwards.

No Bus heat  
Low Bus heat

**Failure to wire the pump correctly will result in failure of the pump.**

The correct wiring is as follows:

**POSITIVE:** Orange lead from booster pump to blue lead on bus harness.

**GROUND:** Black lead from booster pump to the white lead on bus harness.
