Topic	Mulsanne engine control module software update (SC13/07)
Market area	Worldwide Bentley (1WBE)
Brand	Bentley
Transaction No.	2031392/1
Campaign number	E783
Note	
Type	
US code

Mulsanne engine control module software update (SC13/07)

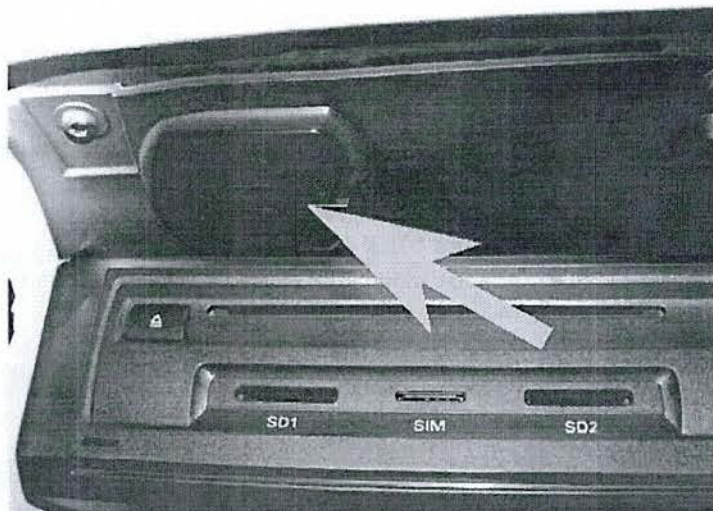
Figure 1

- Locate the key reader, which is in the glovebox, and remove the key reader plastic cover (Figure 1)

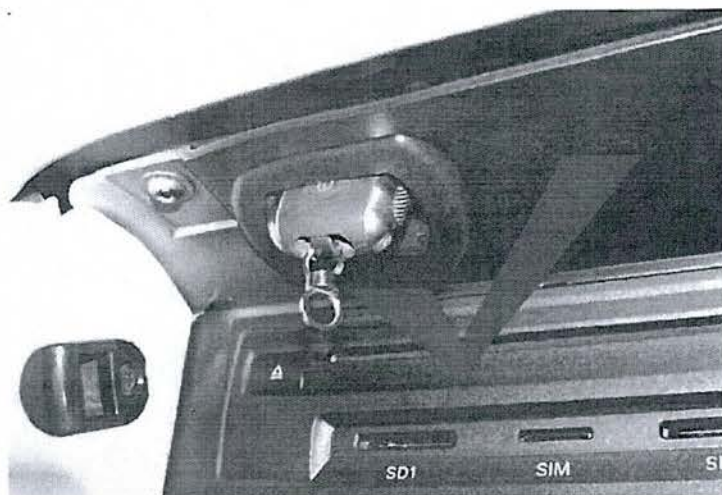
Figure 2

**IMPORTANT:** It is imperative that any adjoining keys etc are removed from the ignition key ring and the single ignition key is used only (Figure 2) as extra weight may cause the key to withdraw from the reader

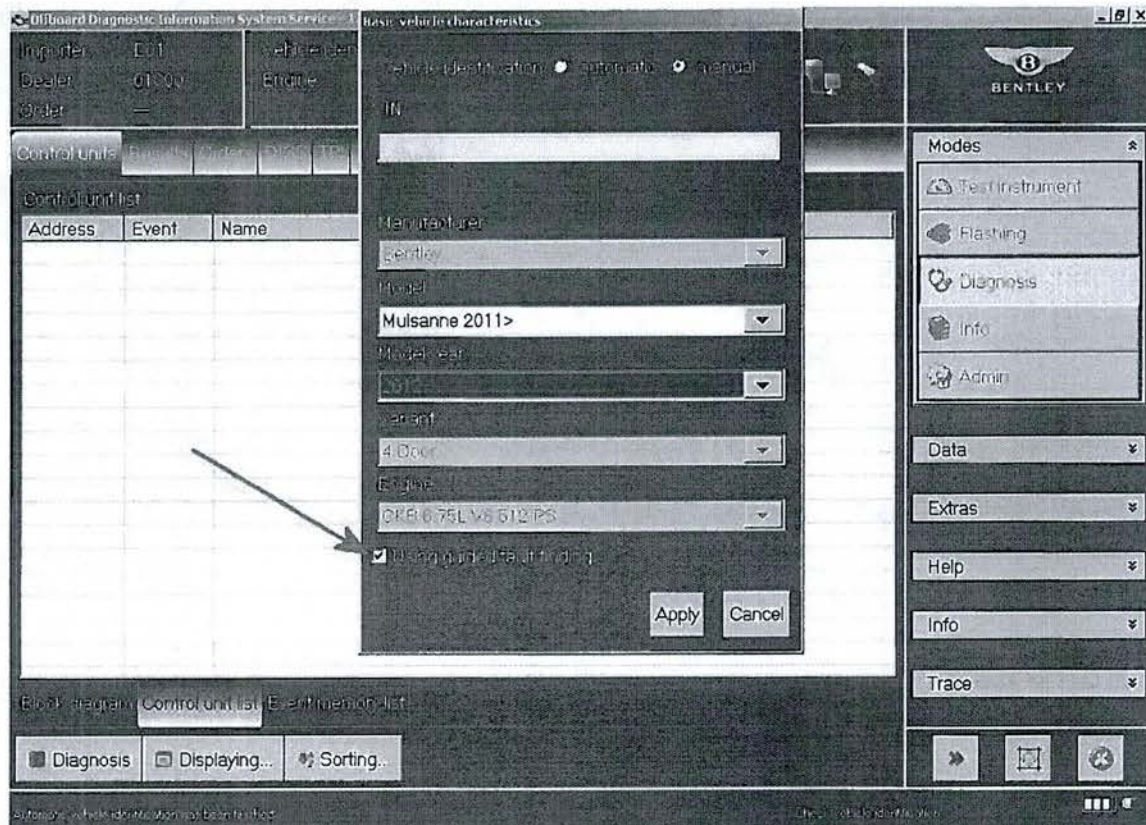
Figure 3

- Ensure the Using guided fault finding box is ticked (Figure 3) - follow all on screen prompts and allow the guided fault finding control module sweep to complete

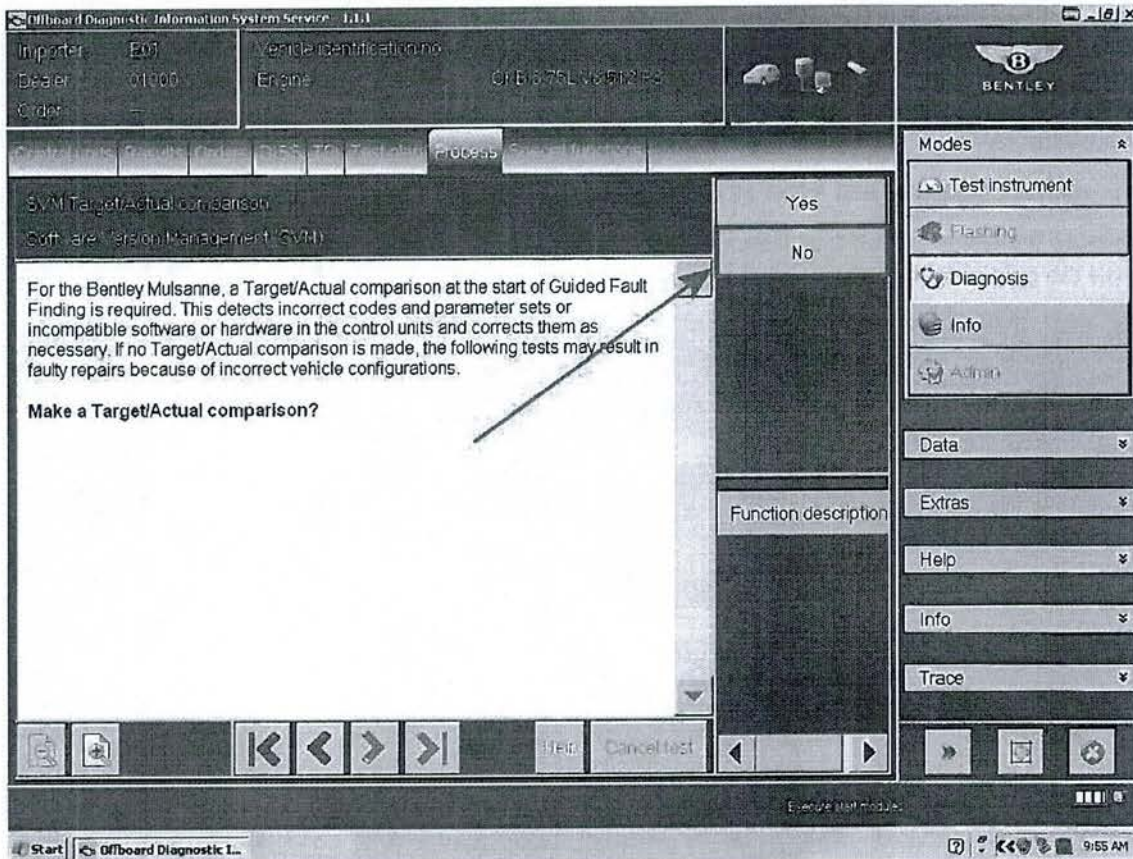
Figure 4

**IMPORTANT:** When requested to Make an SVM Target/ Actual comparison please select No (Figure 4)

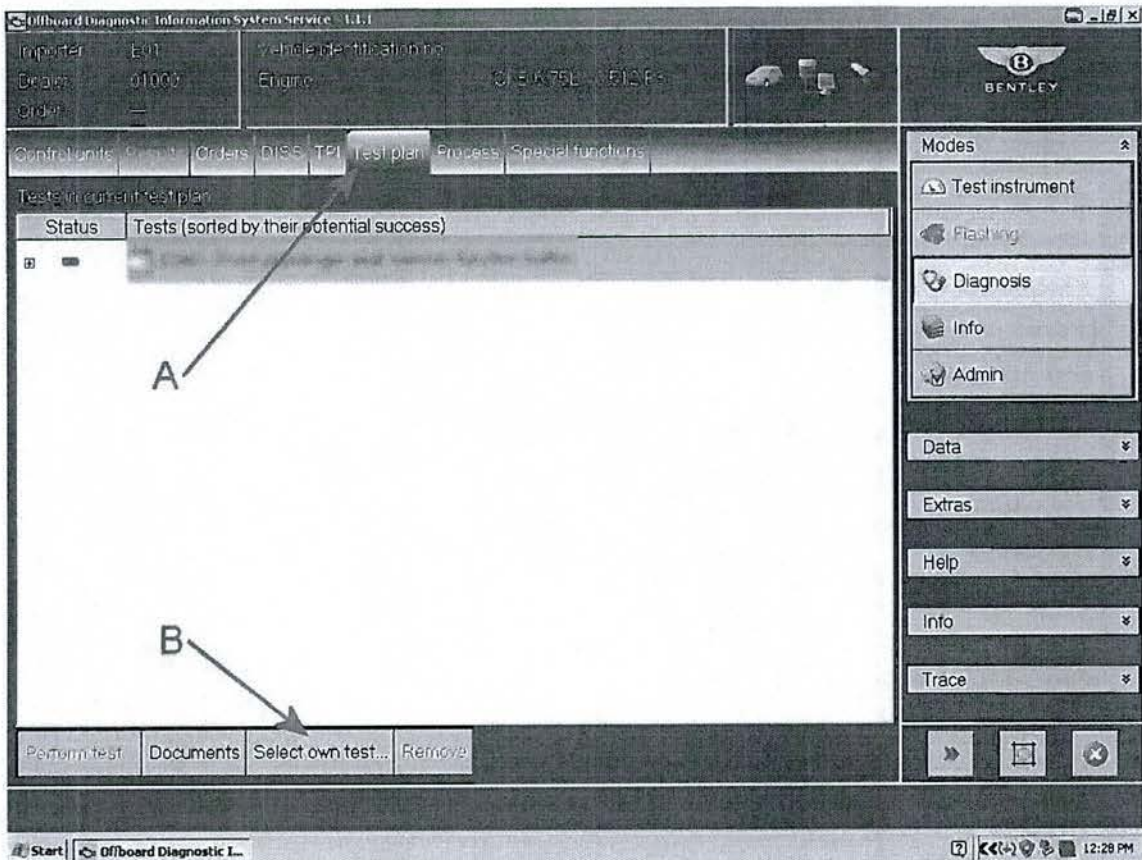
7. Once Guided Fault Finding is complete, Select - Test plan as shown in Figure 5 point A - Select own test as shown in Figure 5 point B, (the overview of tests screen will now appear as shown in Figure 6)

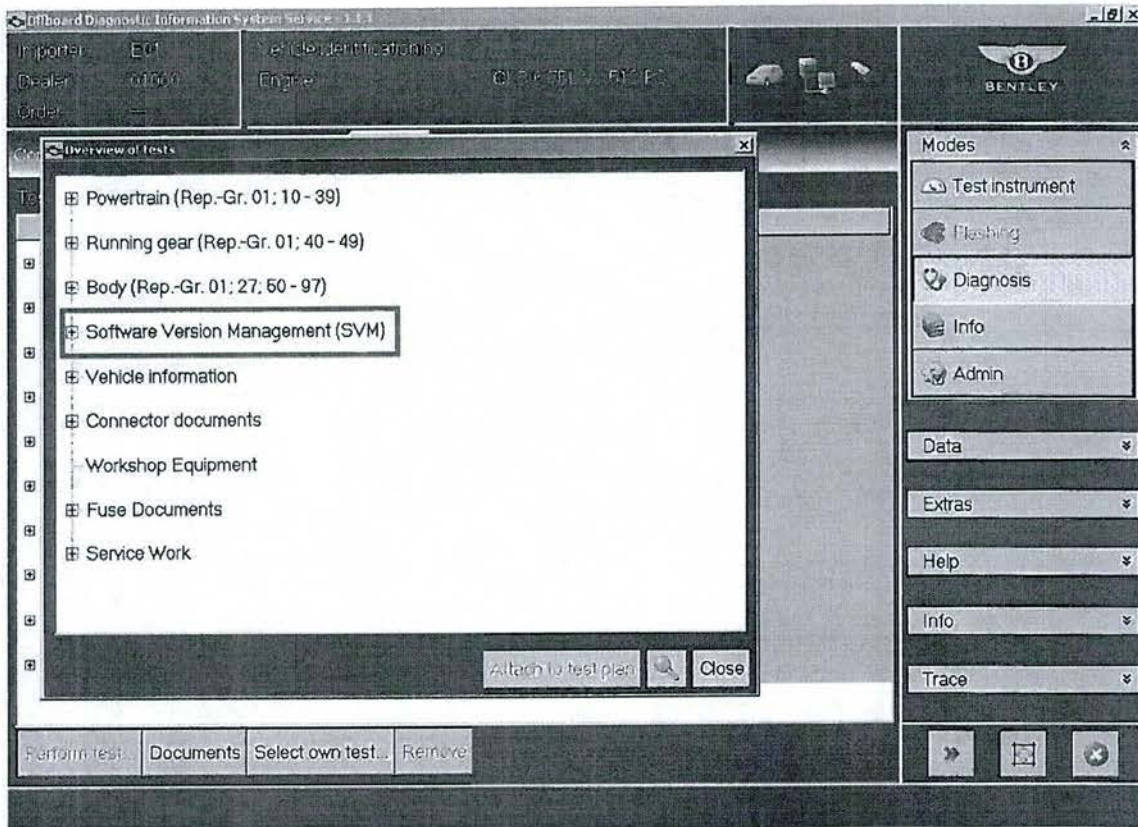
- Referring to Figure 6 - Select +Software Version Management (SVM) a dropdown menu will now appear

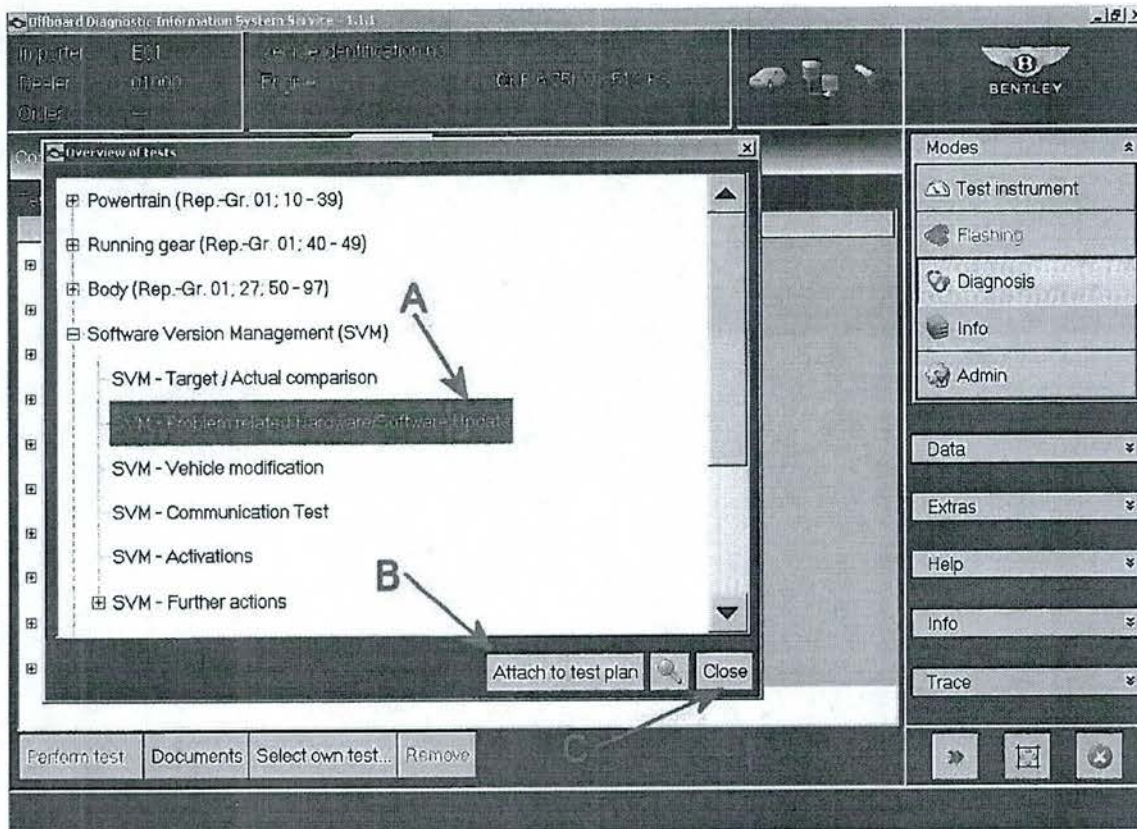
8. Referring to Figure 7 - Select SVM - Problem related Hardware/Software Update (point A), and select Attach to test plan (point B) then select Close (point C)

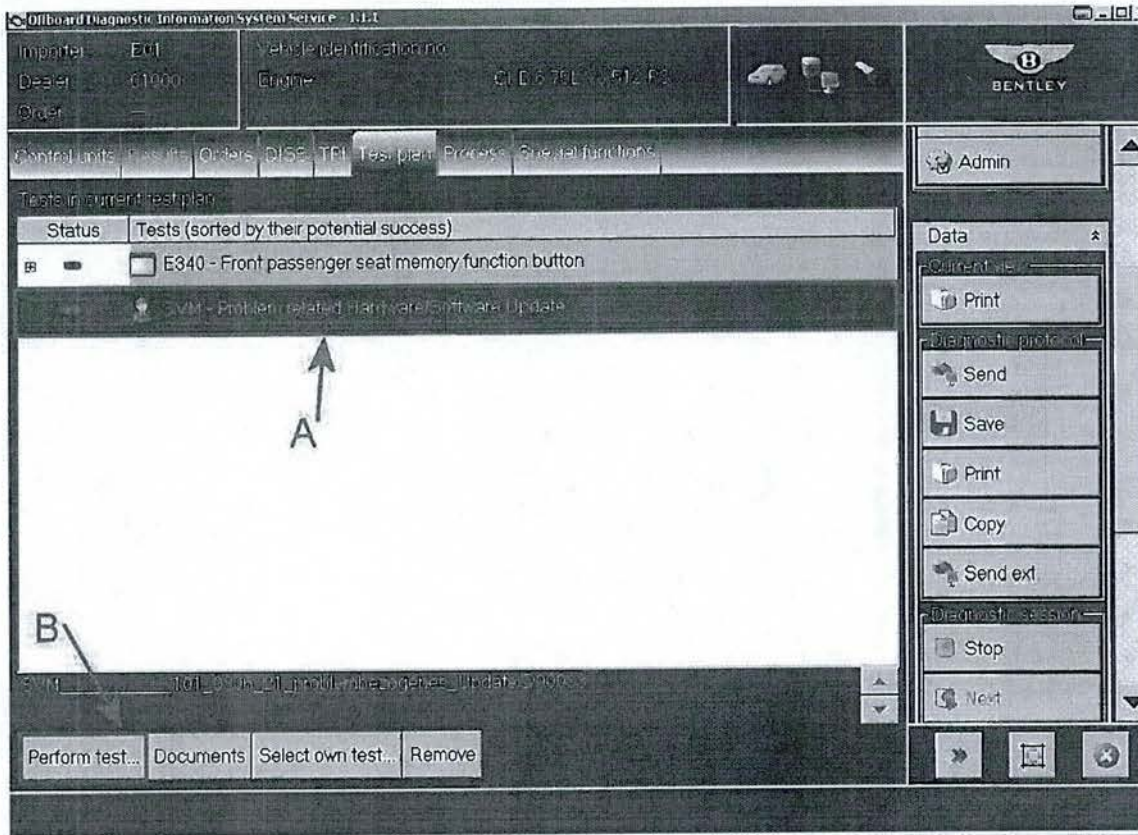
-Referring to Figure 8 ensure the Problem related Hardware/Software update is visible and highlighted as shown at (Point A) and select Perform test (Point B) then follow all on screen prompts

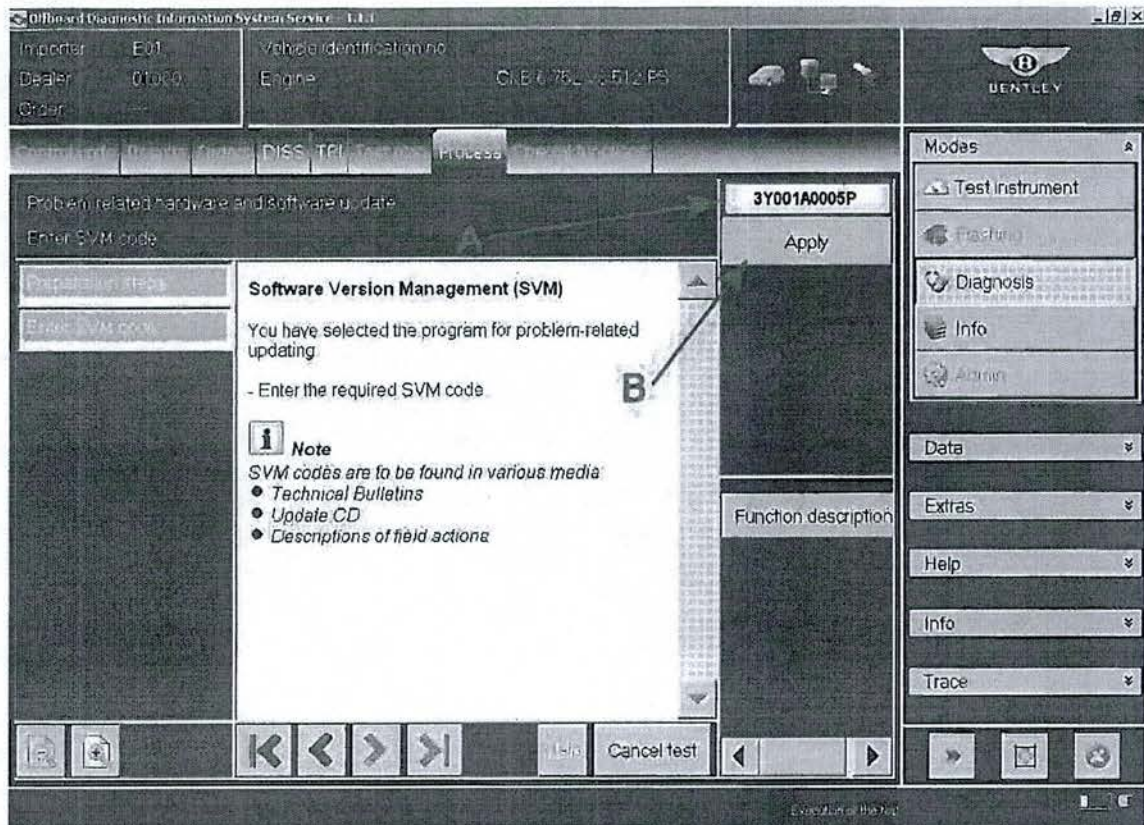
- Once Figure 9 is visible please insert the SVM code 3Y001A0005P (point A) and select Apply (point B) and follow all on screen prompts

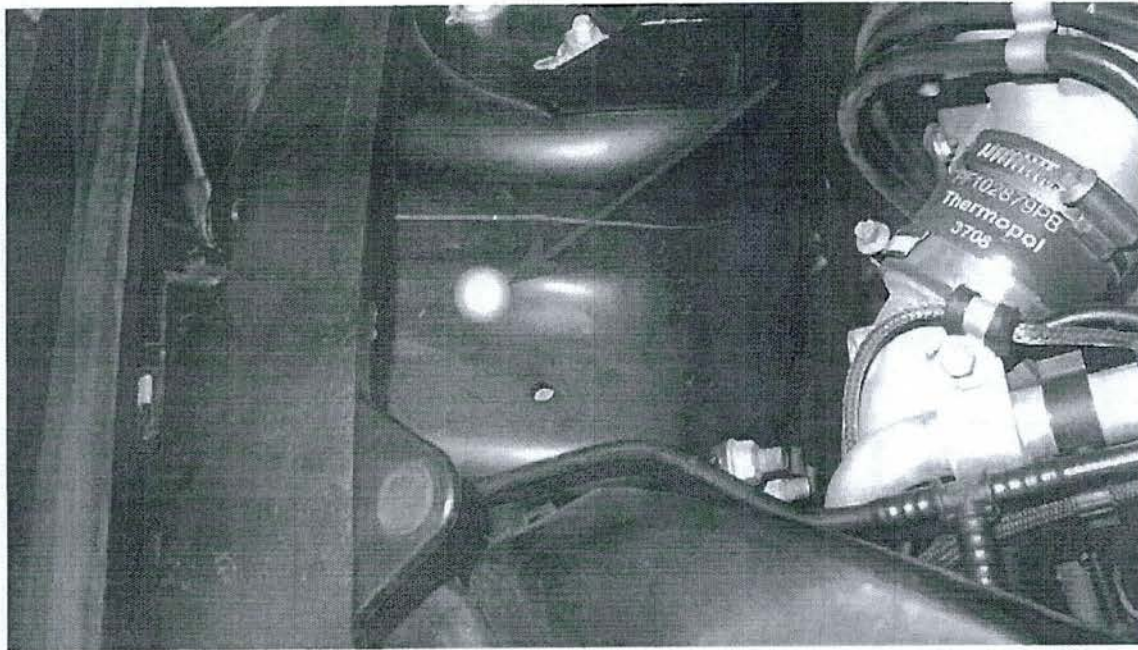
Figure 10

If the vehicle is not already listed as repaired in the "Repair history" (in Elsa Pro) check the base of the right hand strut tower for the White completion mark (Figure 10), if it is evident that the campaign has not been applied carry out the required work in accordance within these instructions.

- Once complete, place a White paint completion mark on the base of the right hand front lower strut tower (Figure 10).

White paint completion mark on the base of the right hand strut tower (Figure 10).
