AFC 13909

Authorized Field Change  
Issued April 2013  
Expires April 2014

## Engine Cooling Fan and Drive Replacement

**Affected Product:** Holiday Rambler 2011½ - 2012 Endeavor & Ambassador and Monaco 2011½ - 2012 Diplomat & Knight

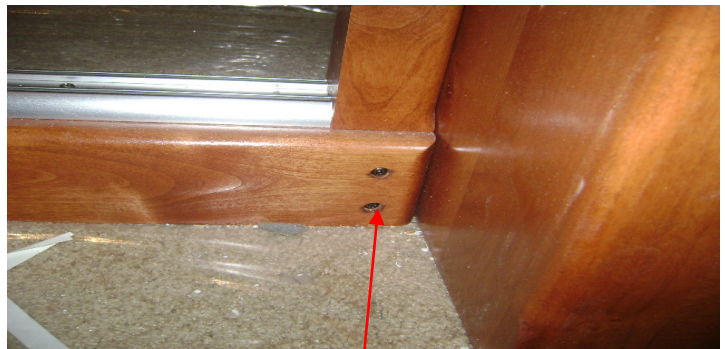
Fig. 1—Remove screws from the toe kick.

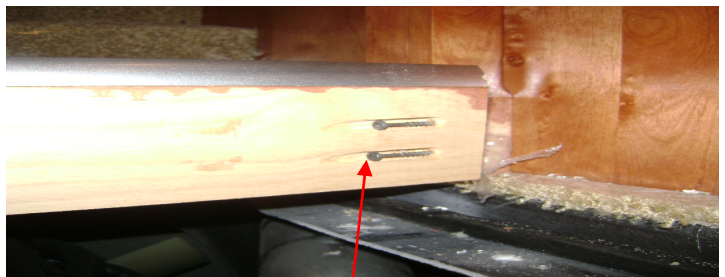
Fig. 2—Remove lower wardrobe track.

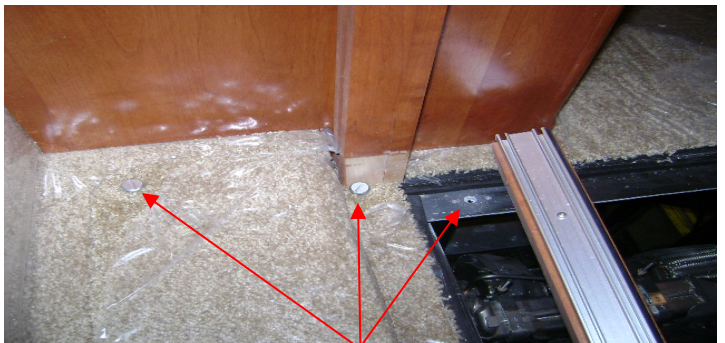
Fig. 3— Remove access covers

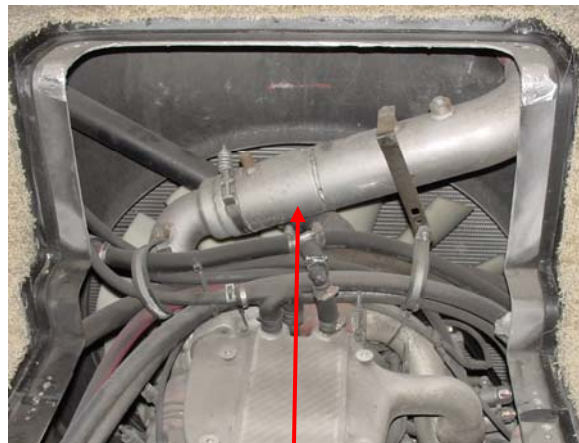
Fig. 4— Remove CAC tube.

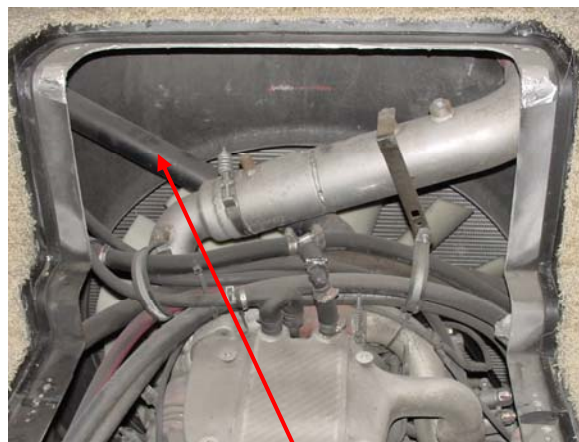
Fig. 5— Remove upper coolant tube .

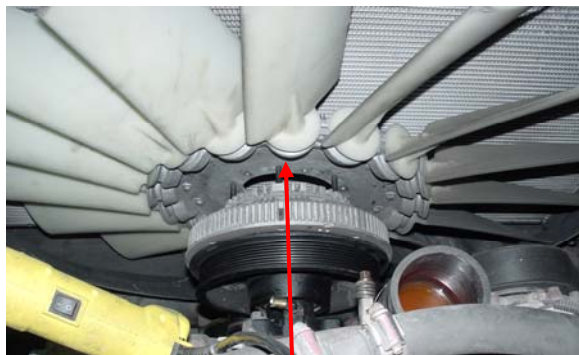
Fig. 6— Remove the engine cooling fan and lean it against the radiator.

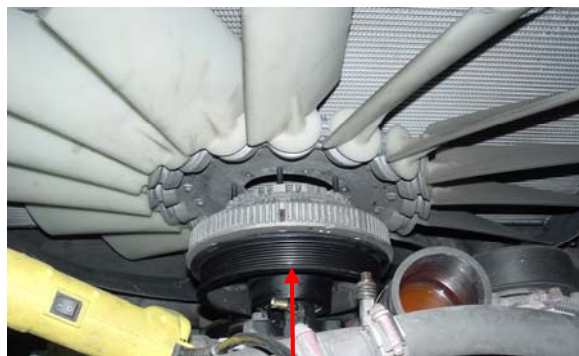
Fig. 7— Remove the fan drive assembly. Note: it will require an additional person to lift the fan drive out and under the vehicle.
