CHRYSLER

June 2013

Customer Satisfaction Notification N20 Engine Torque Rod Bolt

2013 (PF) Dodge Dart

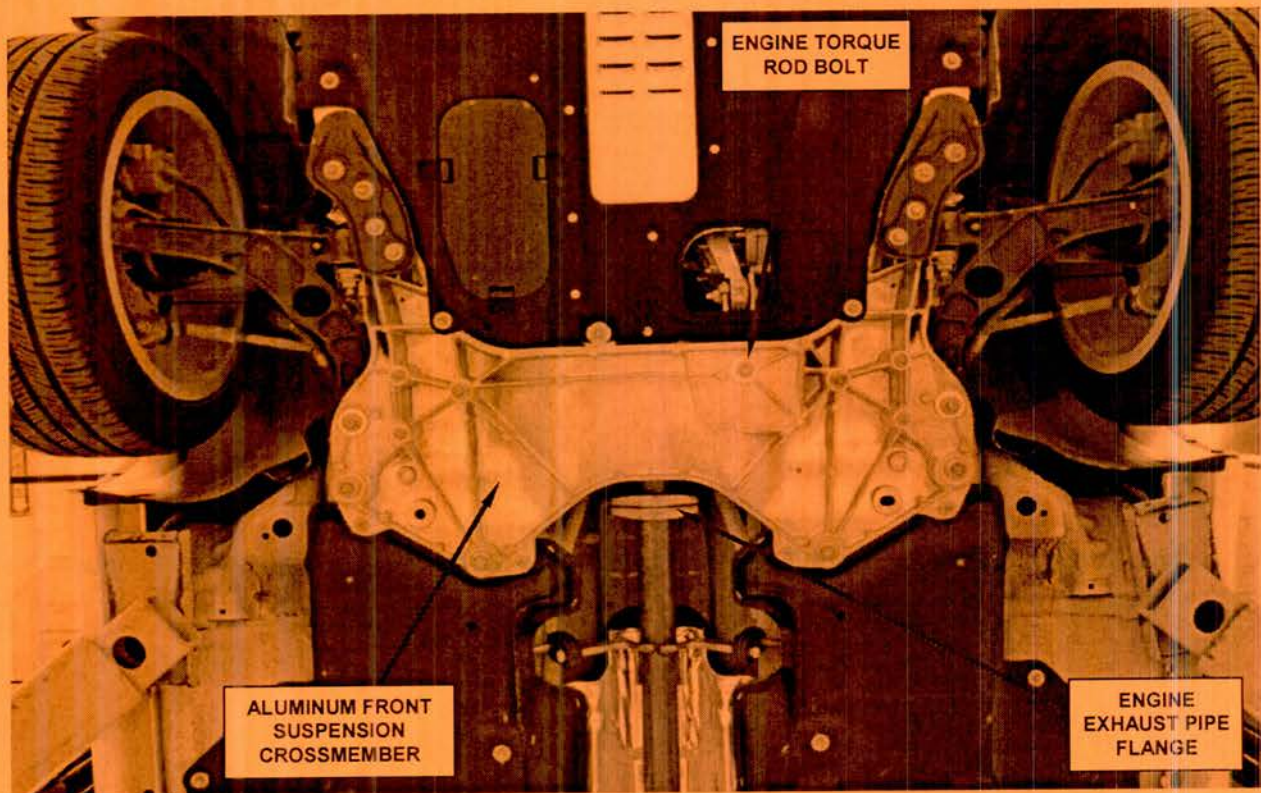
The engine torque rod bolt on about 16,000 of the above vehicles may not have been tightened properly during the manufacturing process. A loose engine torque rod bolt can result in a metallic noise/rattle under certain driving conditions.

Figure 1 – Engine Torque Rod Bolt Location

1. Raise the vehicle on an appropriate hoist.
2. Locate the engine torque rod bolt on the aluminum front suspension crossmember (Figure 1).

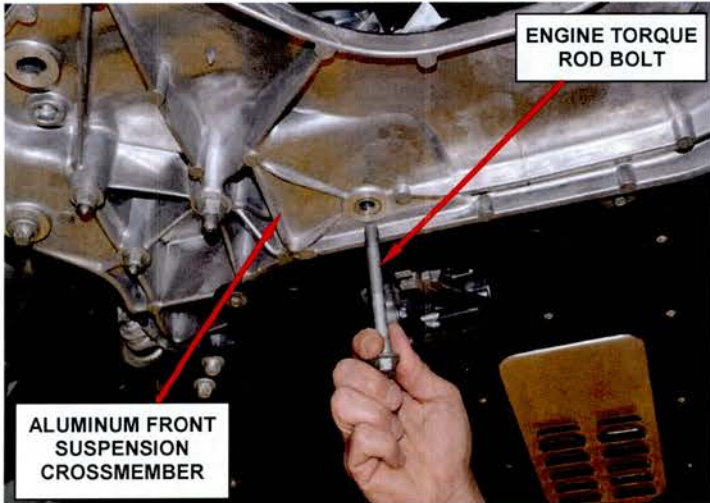
Figure 2 – Remove and Discard Original Bolt

3. Remove and discard the original engine torque rod bolt (Figure 2).
4. Install the new engine torque rod bolt.
5. Using a torque wrench, tighten the engine torque rod bolt to 85 ft. lbs. (115 N·m) (Figure 3).
6. Lower the vehicle from the hoist and return the vehicle to the owner.

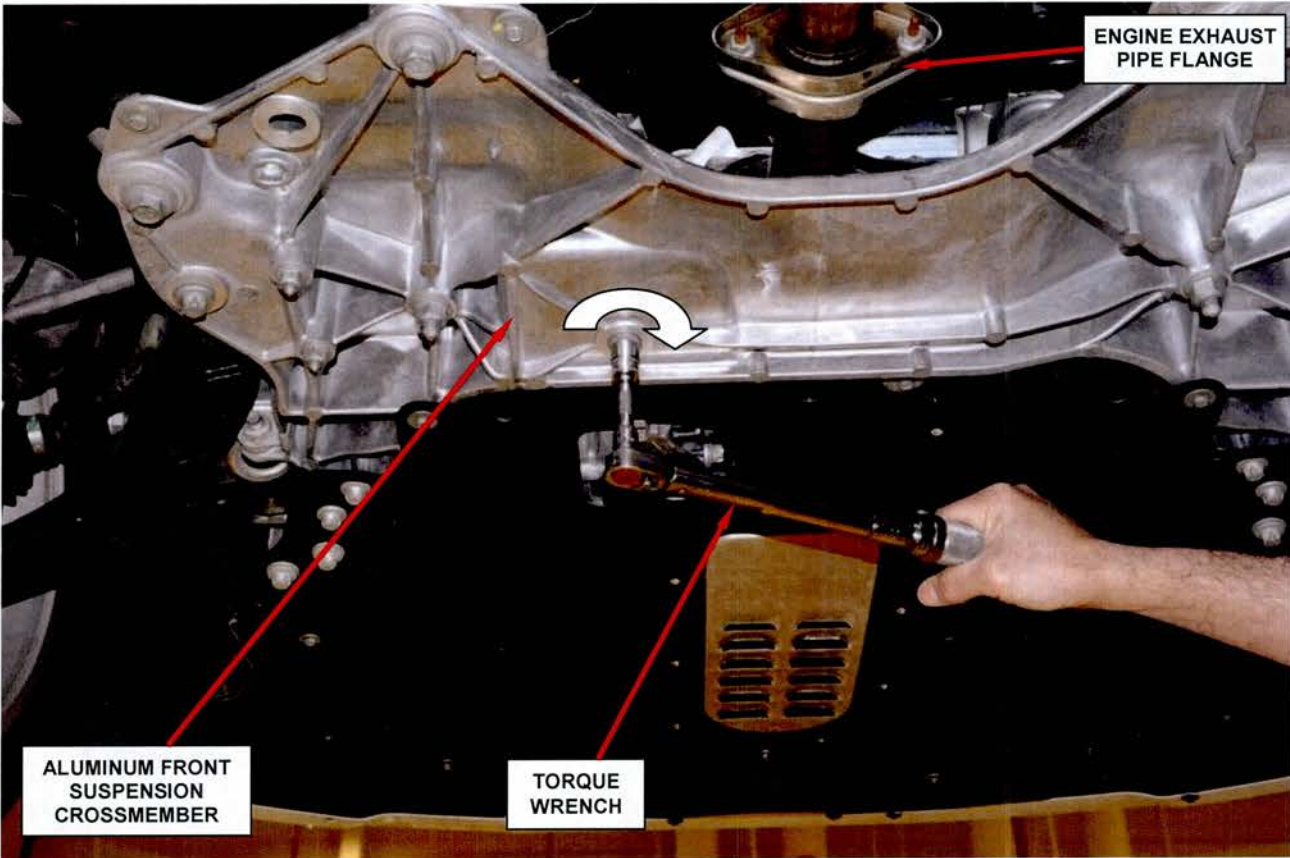
Figure 3 – Tighten New Engine Torque Rod Bolt to 85 ft. lbs. (115 N·m)
