INTERIOR DOOR PANEL RATTLE—ROUGH ROAD SURFACES—BUILT ON OR BEFORE 1/8/2013

TSB 13-5-3

FORD:
2013 Fusion

LINCOLN:
2013 MKZ

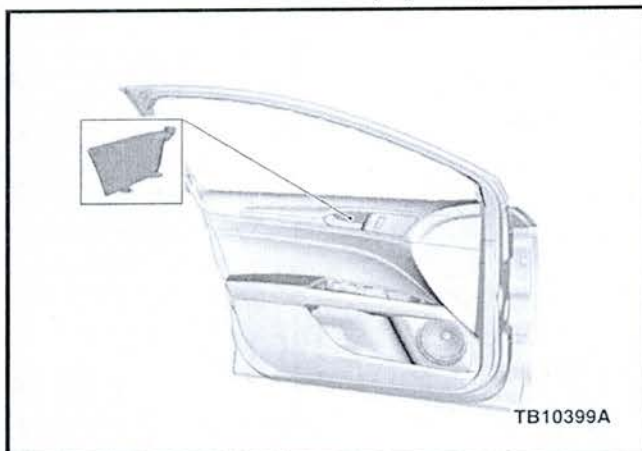
Figure 1 - Article 13-5-3

Some 2013 Fusion and MKZ vehicles built on or before 1/8/2013 may exhibit a rattle noise from the interior door panel area over rough road surfaces. This noise can be isolated to the trim cover behind the interior door handle on any of the four doors.

1. Remove door trim cover. (Figure 1)

- a. Using a suitable tool, pull the front of the trim cover first to prevent damage.
 - b. If any of the four tabs are broken, replace the trim cover. Proceed to step 2.
2. From the Rotunda Squeak and Rattle Kit (part number 164-R4900) select one PVC soft foam tape strip (part number 164-R4901).
 - a. Cut a foam tape strip to a size of 10 mm (3/8") wide by 25.4 mm (1") long and apply it to the back side of the cover. (Figure 2)
