MALFUNCTION INDICATOR LAMP (MIL) ILLUMINATED—DTCS P0135 AND P0155— BUILT ON OR BEFORE 11/31/2011

TSB 13-5-7

FORD:
2012 Expedition

LINCOLN:
2012 Navigator

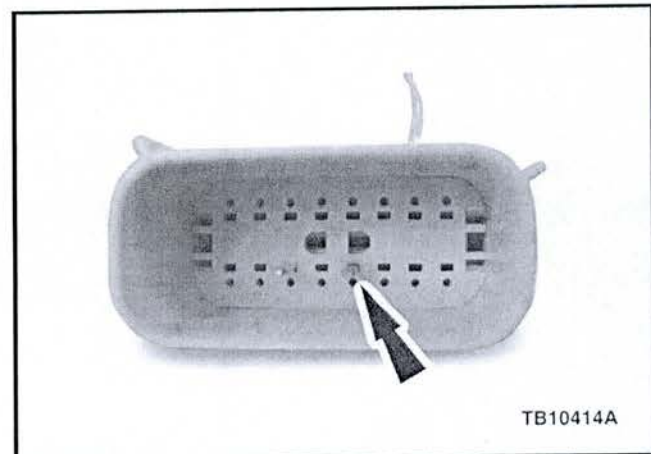
Figure 1 - Article 13-5-7

2. Locate C146 in the right rear corner of the engine compartment. Separate the connector and inspect the pins carefully for signs of contamination, discoloration and/or moisture intrusion. Refer to Wiring Diagram, Section 152-1. (Figure 1)

3. Is contamination present?
 - a. Yes - proceed to Step 4.
 - b. No - this article does not apply. Refer to PC/ED Manual for normal diagnostics.
4. Replace connector pigtails on both the female and male sides following desired splicing method. Refer to Wiring Diagram, Section 5-1.

5. Apply Motorcraft® Electrical Grease to the connector terminals.
6. Install the original harness retainer on the male connector and secure the harness.
