3.5L GTDI—INTERMITTENT STUMBLE/MISFIRE ON ACCELERATION FROM HIGHWAY CRUISE IN HUMID OR DAMP CONDITIONS WITH POSSIBLE DTC P0304, P0305, P0306, OR P0430

TSB 13-8-1

2011-2012 F-150

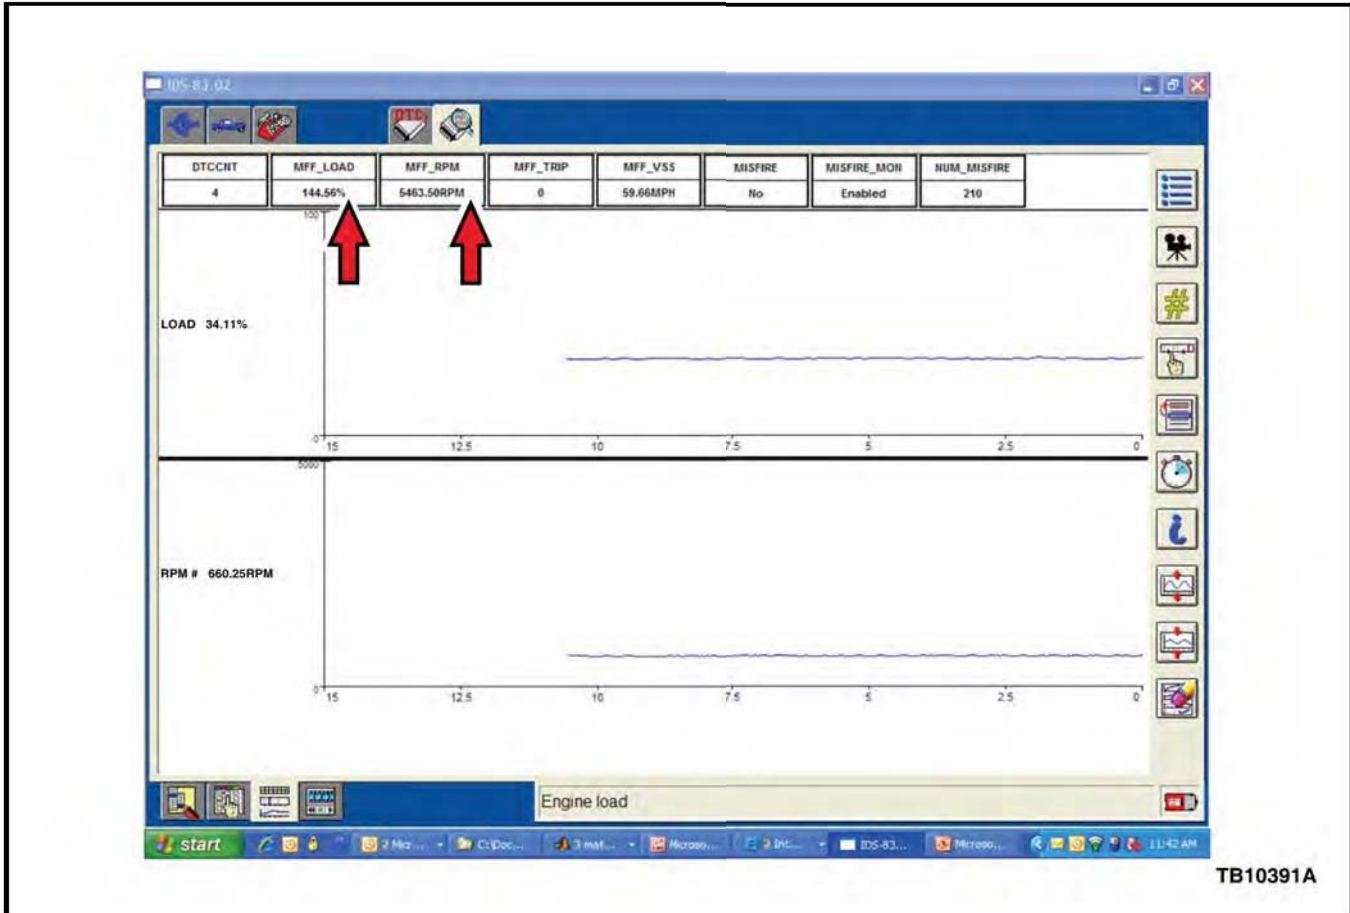
Figure 1 - Article 13-8-1

- a. Select Toolbox
 - b. Then Data Logger
 - c. Then Modules
 - d. Then PCM
 - e. Next, select the following PIDs: MFF_LOAD and MFF_RPM.
2. Is the misfire concern only repeatable in humid or damp conditions?
 - a. Yes - Proceed to Step 3.
 - b. No - This article does not apply. Refer to Powertrain Control/Emissions Diagnosis (PC/ED) Manual Section 3: Powertrain Symptom Index to inspect such areas as Ignition, Compression, and Injection.
 3. Does the Misfire Freeze Frame Data indicate engine speed above 2500 rpm and load 100% or above? (Figure 1)

- a. Yes - Proceed to Step 4.
 - b. No - This article does not apply. Refer to PC/ED Manual Section 3: Powertrain Symptom Index to inspect such areas as Ignition, Compression, and Injection.
4. Is vehicle equipped with latest level charge air cooler, engineering part number BL34-9L440-AE? (Figure 2)

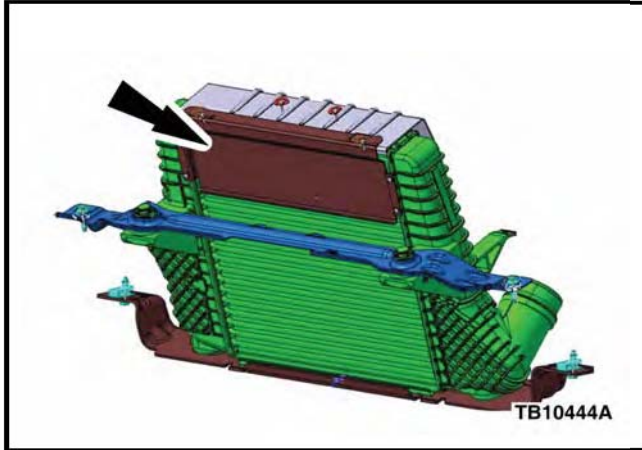
Figure 3 - Article 13-8-1

- 5. Is DTC P0430 present?
 - a. Yes - replace the left hand catalytic converter. Refer to Workshop Manual (WSM), Section 309-00. Proceed to Step 6.
 - b. No - Proceed to Step 6.
- 6. Is the Charge Air Cooler equipped with the top air deflector? (Figure 3)

- a. Yes - remove and discard. Refer to WSM, Section 303-12. Proceed to Step 7.
 - b. No - Proceed to Step 7.
7. Install revised bottom air deflector.
- a. Make sure that the lower forward facing bottom seven (7) tubes and eight (8) rows of fins on the Charge Air Cooler are dry and free of dirt and debris. (Figure 4)
