SB-10052809-1509

Title: Reinforcement of the Battery Box CE RE FE and BE Buses

Applies To: Model: Bus Start Date: 03/09/1999 End Date: 12/12/2006

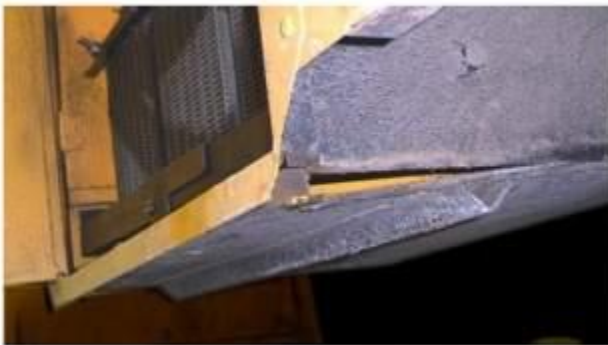
On some bus models the bottom of the battery box may deform, or begin to separate from the sides of the box under the weight of the vehicle's batteries. A field kit that contains two corner supports and fasteners, for reinforcement of the battery box is now available to address this issue.

Before Repair

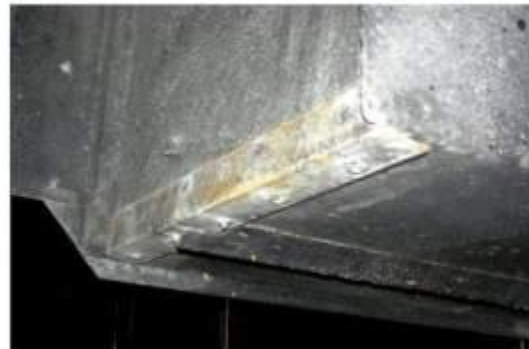
After Repair

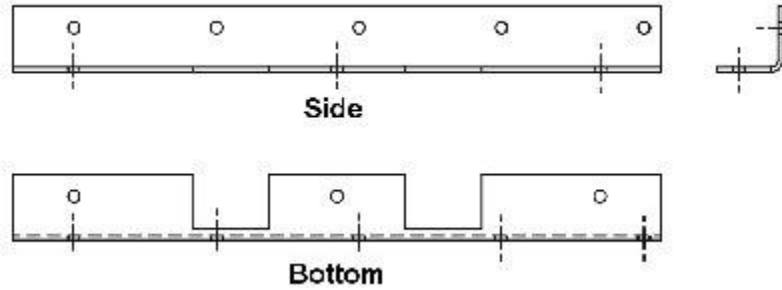
Brackets in kit

2592801C1	Support, Reinforcement Angle (Figure 2)	2
424329001	Rivet, 1/4 Huck Magna Bulb (Figure 3)	16
