Service Bulletin

Bulletin No.: 09-08-42-005D

Subject: Driver/Passenger Door and/or IP Accent Lighting – Light Bar (Pipe) Inoperative or Loses Intensity

Models: 2010-2014 Chevrolet Camaro
Equipped with Light Piped Door Trim (RPO FCR)

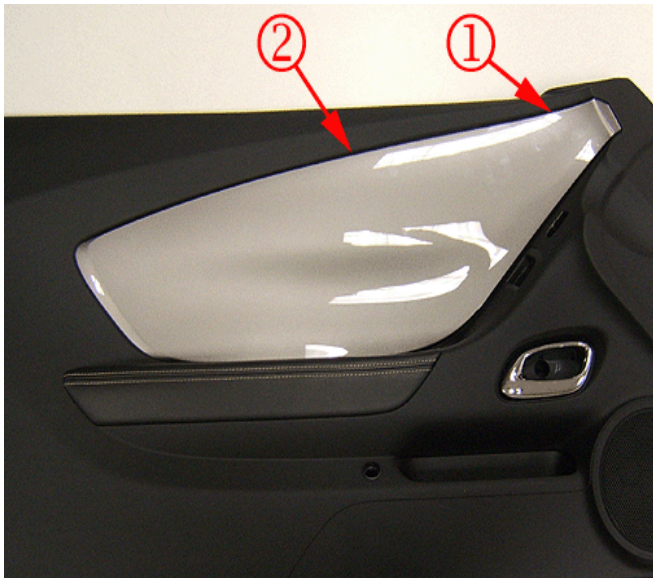
2294397

The normal operation of the door accent lighting is the light will be brightest at the rear of the door panel and gradually lose intensity until approximately 76 mm (3 in) (1) from the front edge of the trim panel. The lighting does not carry on to or across the instrument panel. If the light stops at the center of the door (2), proceed with this bulletin.

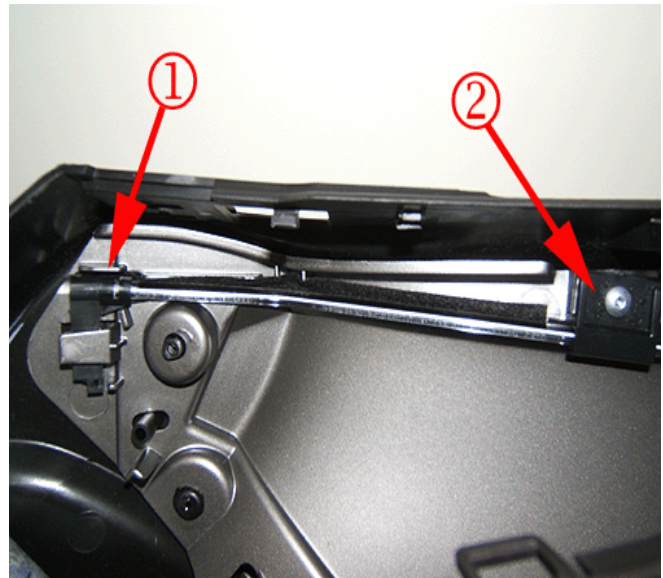
2294398

If the light stops at the center of the door, remove the trim panel and make sure the light bar (pipe):

1. Is in the channel
2. Has not dipped down
3. Is properly retained by the retaining clips (2)
4. End cap (1) is properly installed

To verify normal operation, apply 12 volts to the connector and make sure the light is brightest at the rear of the panel and gradually dims towards the front of the door panel.

If the light bar (pipe) is not illuminated the full length, is noticeably different from side to side or inoperative, replace the lamp-harness assembly. There are two different part numbers based on the illumination color of the lamp.
