# Service Bulletin

**Subject:** Click Noise Heard from Front Compartment Area, Possible DTC P059F Set

**Models:** 2014 Chevrolet Spark EV  
**Condition/Concern**

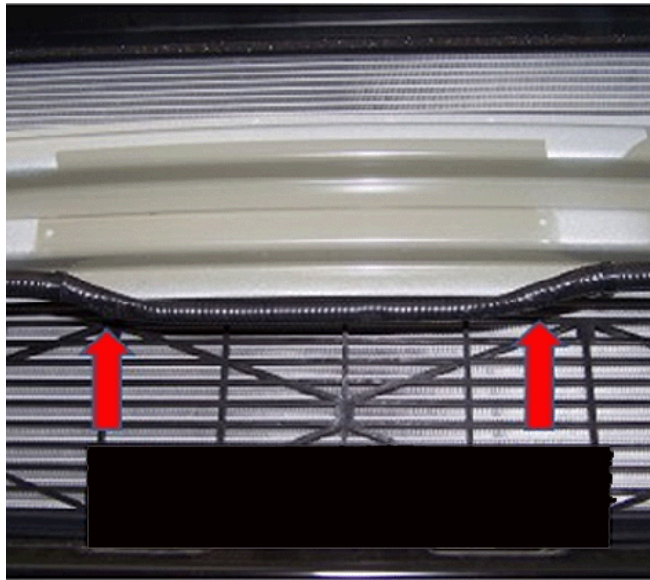
3596939

This condition may be caused by the harness dropping down during installation of the front fascia and causing the air shutter housing to be pushed down and contact the louvers when opening or closing.

The above graphic shows the pinched portion of the harness where it has dropped down and pushed on top of the louver housing causing contact.
