CHRYSLER

Safety Recall N51 / NHTSA 13V-358

Halfshaft-to-Gearbox Output Flange Fasteners

2013 (FF) Fiat 500E (Battery Electric Vehicles)

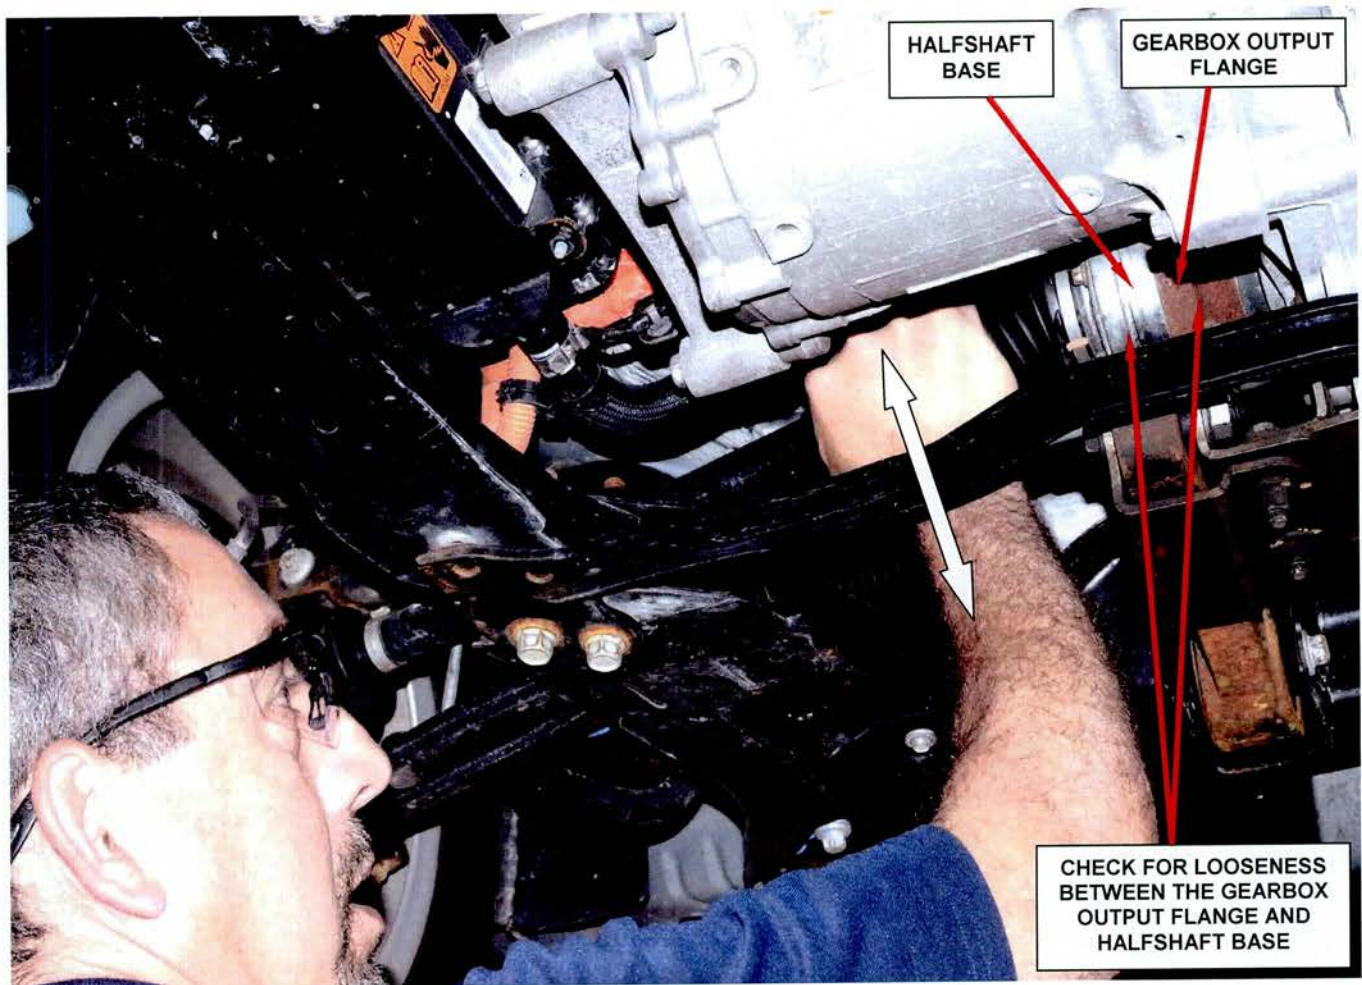
**Figure 1 – Check for Looseness
(right side shown)**

1. Lift the vehicle on an appropriate hoist.
2. Check both halfshafts for looseness at the gearbox output flange and halfshaft base (Figure 1):
 - If the halfshafts are not loose, continue to **Section C. Replace Halfshaft Fasteners**.
 - If one or both halfshafts are loose, continue with Step 3 of this procedure.

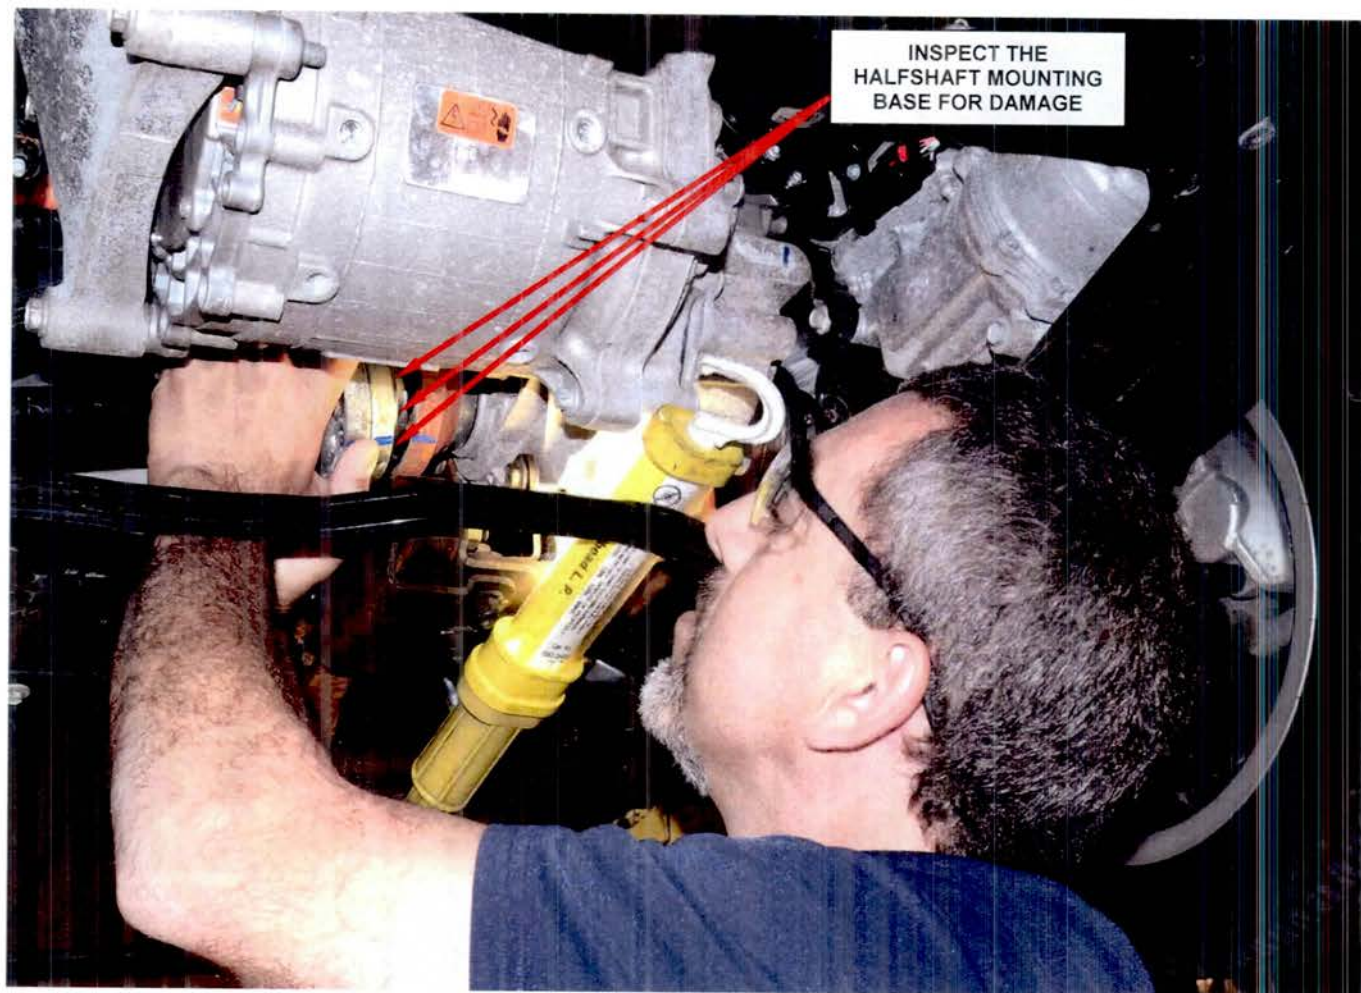
Figure 2 – Inspect the Halfshaft Base Mounting Surface (right side shown)

3. Mark the halfshaft orientation to the gearbox output flange on the loose halfshaft.
4. Remove and discard the six halfshaft-to-gearbox output flange fasteners.
5. Pull the halfshaft away from the gearbox output flange and inspect the mounting surface of the halfshaft base (Figure 2):
 - If the halfshaft mounting surface is not damaged, continue to Step 6 of this procedure.
 - If the halfshaft mounting surface is damaged, continue with **Section B. Replace Halfshaft(s)**.

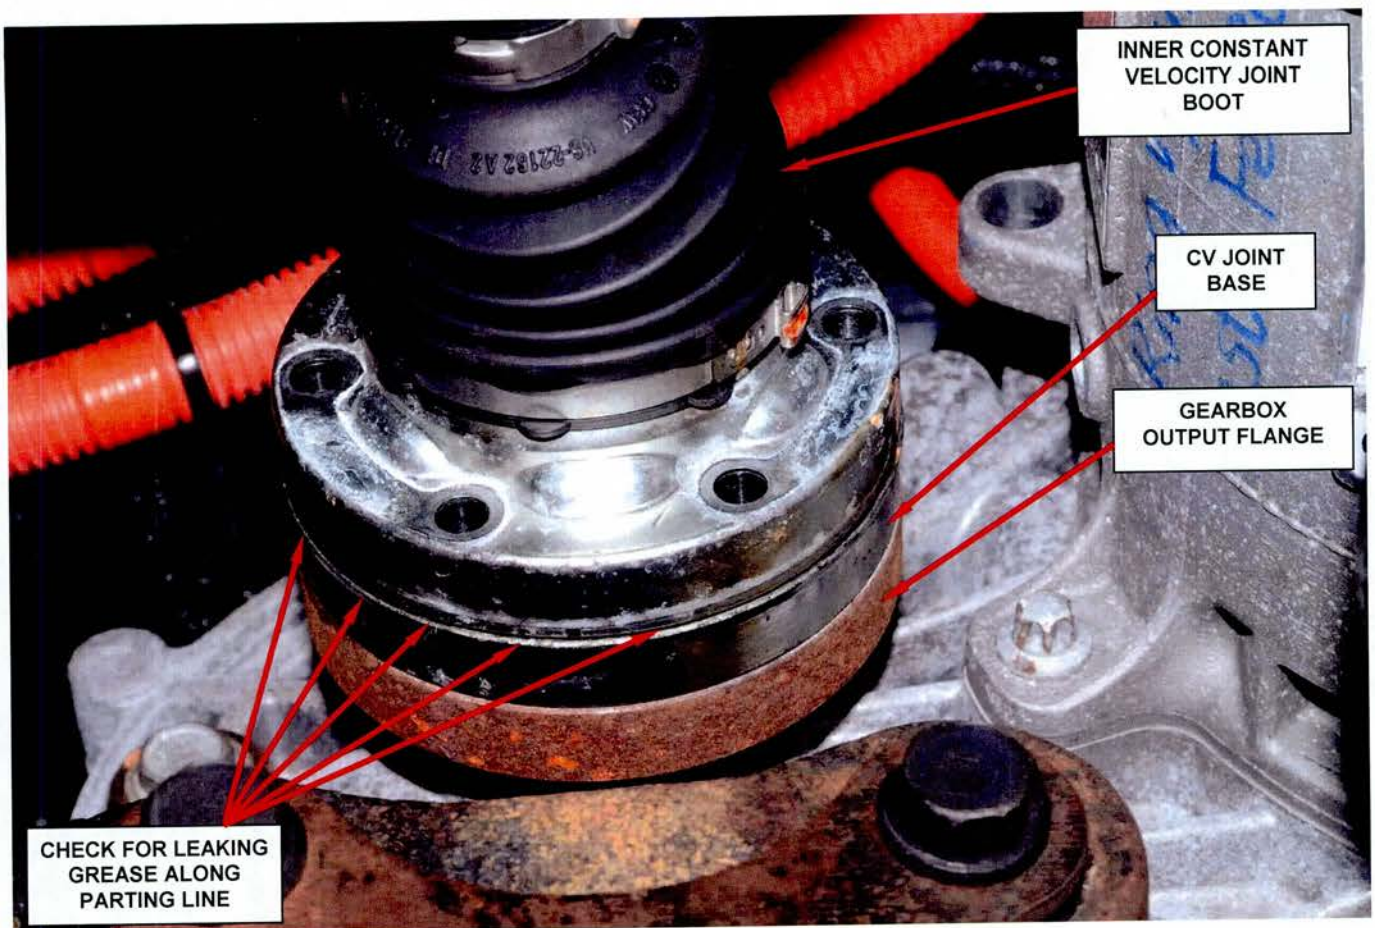
Figure 3 – Inspect for Leaking Grease at Halfshaft Base Seam

6. Inspect the halfshaft for grease leaks at the halfshaft CV joint base (Figure 3):
 - If there is no grease leaking from the halfshaft CV joint base, continue with **Section C. Replace Halfshaft Fasteners.**
 - If there is grease leaking from the halfshaft CV joint base, continue with **Section B. Replace Halfshaft(s).**
