REDUCED FUEL TANK CAPACITY—EMPTY REFILL 38 TO 45 LITERS (10 TO 12 GALLONS)- BUILT ON OR BEFORE 4/2/2013

TSB 13-6-3

FORD:
2013 Fusion

LINCOLN:
2013 MKZ

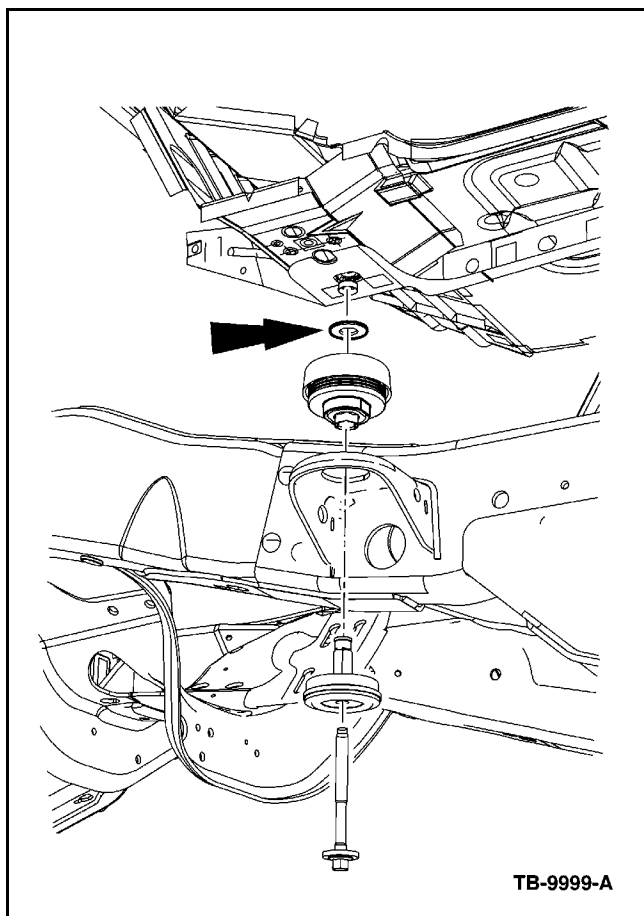
Figure 1 - Article 13-6-7

- a. Yes - proceed to Step 4.
 - b. No - this article does not apply. Refer to (WSM), Section 100-04 for normal diagnostics.
4. Determine vehicle model year and built date.
 - a. 2008-2010 vehicles proceed to Step 5.
 - b. 2011 and 2012 vehicles built on or before 05/01/2012 proceed to Step 13.
 5. Loosen all body support mount bolts from the affected side except the front end sheet mount located behind the front bumper.
 6. Raise vehicle cab slightly approximately 25 mm (1").
 7. Remove the number 1 body support mount(s) on the affected side of the vehicle only. Refer to WSM, Section 502-02.
 8. Use a wire wheel to clean all threadlock material from the threads of the bolts.
 9. Install a shim between the floor pan and number 1 upper body support mount that exhibits the noise. (Figure 1)

10. Lower vehicle cab.
11. Apply Motorcraft® Threadlock and Sealer to the threads of the body support mount bolts.
12. Reinstall the body support mount bolts number 2, 3 and 4 and torque to 103 N•m (76 lb-ft). Refer to WSM, Section 502-02.
13. Replace the No. 1 lower body support mount(s). Refer to (WSM) Section 502-02.
 - a. Apply Motorcraft® Threadlock and Sealer to the threads of all body support mount bolt(s).
