Service Bulletin

Bulletin No.: PI1026

Subject: Reduced Engine Power, No Crank/No Start, Service Stabilitrak Message, Electric Parking Brake Light On, Liftgate Inoperative, Various Communication DTCs

Models: 2010-2013 Cadillac SRX
2013 Cadillac XTS
2013 Chevrolet Malibu

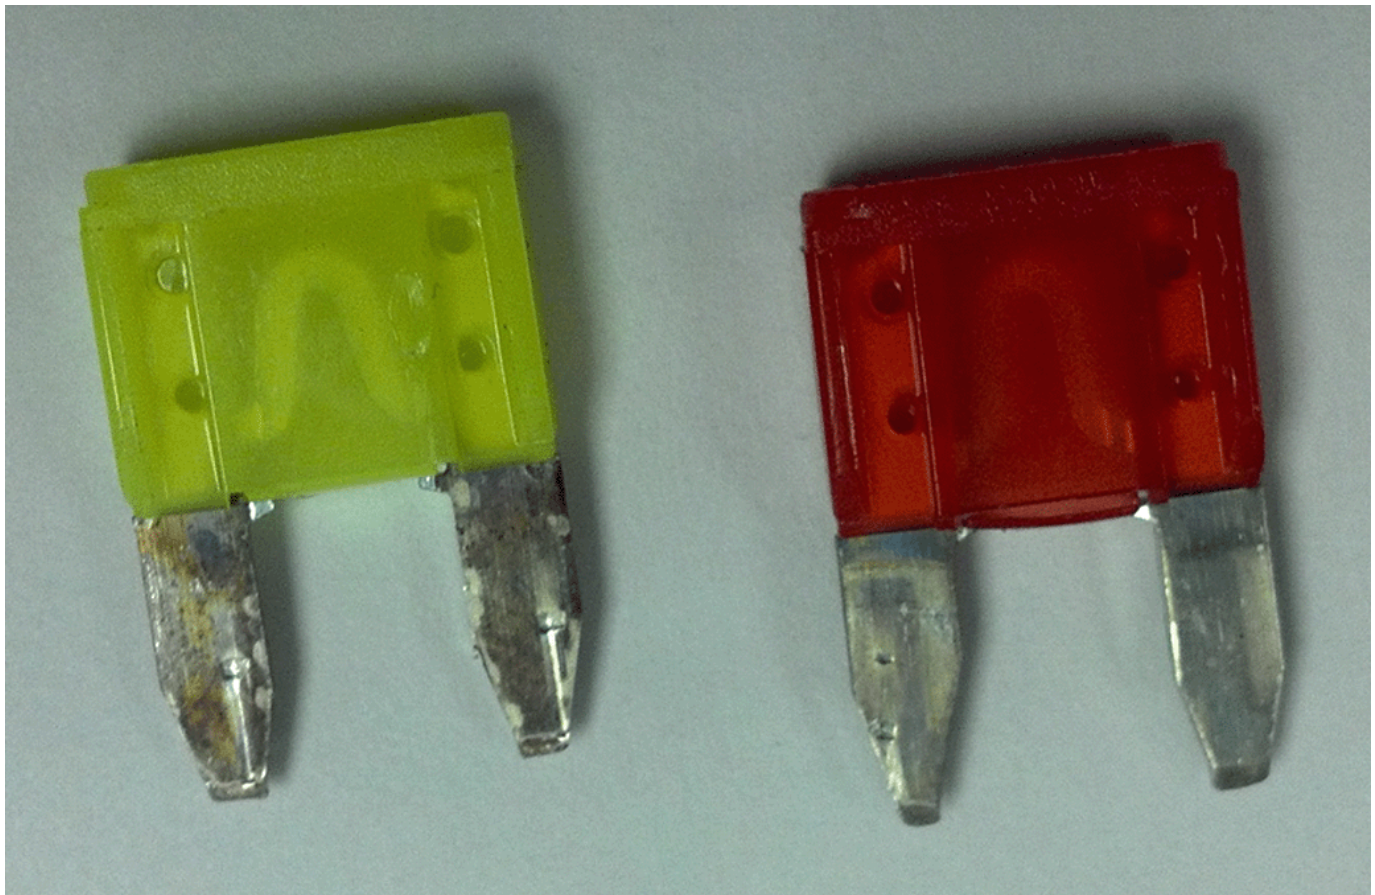
3406690

These concerns may be caused by poor terminal contact between the fuse and the fuse block.

Technicians should remove the ECM_BATT and TCM_BATT fuses from the underhood fuse block and inspect each fuse terminal for contact witness marks (scratches).

- If there are no contact witness marks (as shown above on the fuse on the right) on both terminals of either fuse, replace the underhood fuse block. Refer to the Fuse Block Replacement procedure in SI.
- If there are witness marks on both terminals of each fuse, refer to SI for further diagnostics.
