TITLE:  
**Electronic Park Brake, Not possible to get brake caliper into service position**

REF NO: <b>TJ 27500</b>	ISSUING DEPARTMENT: <b>Technical Service</b>	CAR MARKET: <b>United States and Canada</b>
PARTNER: <b>3 US 7510 Volvo Cars North America</b>		ISSUE DATE: YEAR      MONTH      DAY <b>2013          07          30</b>
FUNC GROUP: <b>5127</b>	FUNC DESC: <b>Brake caliper</b>	<b>Page 1 of 4</b>

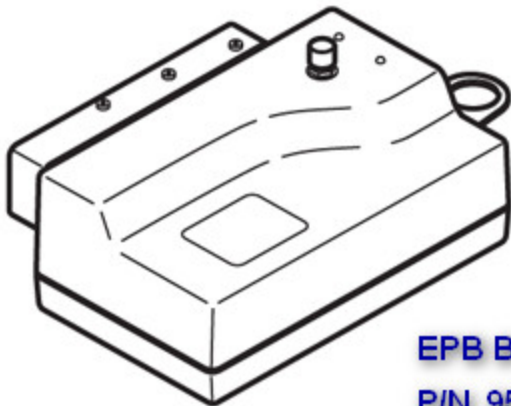
EPB Box

- *Release the electric parking brakes by using the special release tool PN 3513014 (see picture), which will override the PBM control unit.*
- *If the special tool is not available: close all doors, lock the car, wait at least one minute, unlock the car, open one door and try again with VIDA activation,*
- *Repeat the above if necessary.*
