Service Bulletin

Bulletin No.: 08-08-67-013H

Subject: Snap, Pop, Creak or Rattle Noise from Lift Off Roof Panel While Driving
(Verify Condition and Perform Appropriate Repairs)

Models: 2005-2013 Chevrolet Corvette
Equipped with Removable Clear Roof Panel RPO CC3, Removable Sun Roof Panel
RPO CF7 or Dual Removable Roof Panels RPO C2L

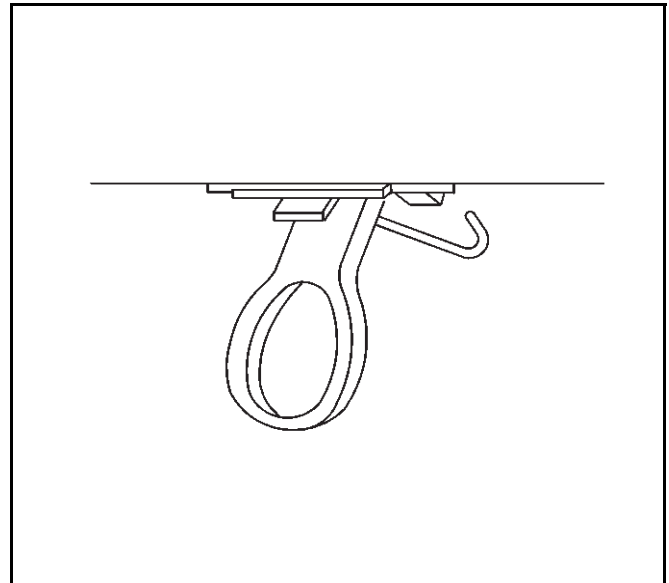
167241

- Insufficient clearance between the lift off roof panel and the leading edge of the rear roof bow.
- Possible crack at the rear edge of the lift off roof panel.
- Insufficient tension on the roof rear latching mechanism.

1. Verify there is sufficient gap, and that the lift off roof panel is not hitting the leading edge of the rear roof bow. If this condition exists, adjust the roof panel. Refer to Roof Lift Off Panel Adjustment in SI.
2. Inspect the rear edge of the lift off roof panel for cracks or chips. If a roof panel is dropped, or has been set down hard on the rear edge, it may crack the edge and cause a noise.

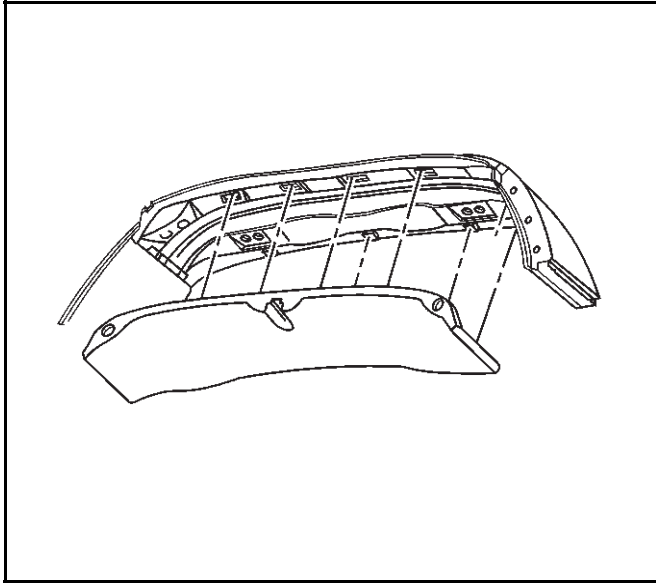
71202

The rear locator pins on the lift off roof panel may be loose, or someone may have attempted to adjust the height of the roof panel to this location.

1. Remove the rear roof bow trim panel. Refer to Rear Roof Bow Trim Panel Replacement in SI.

2. Verify proper alignment of the rear locator pins and the rear locators. Refer to Roof Lift Off Panel Adjustment in SI.

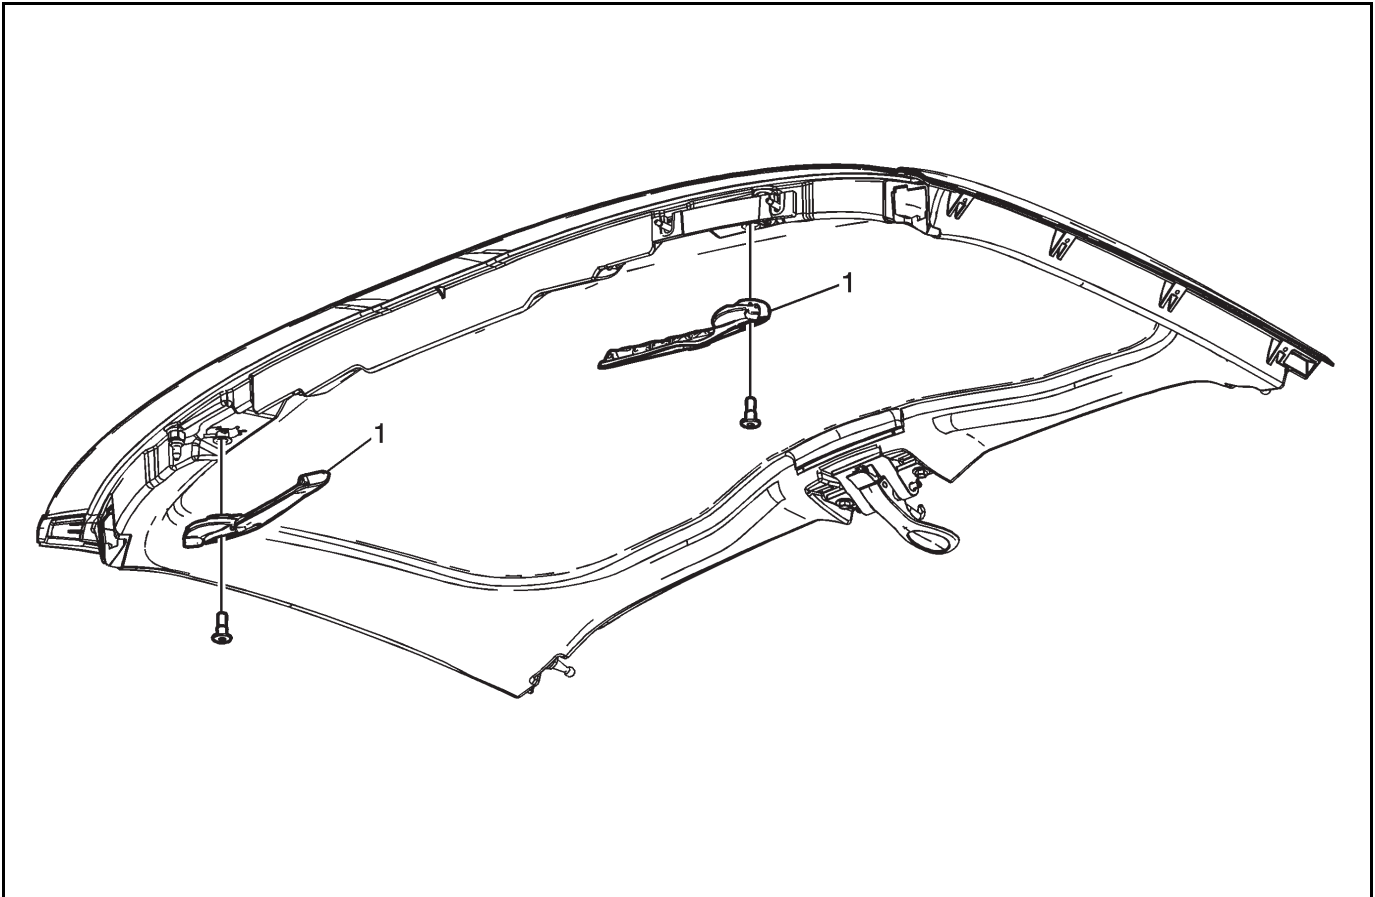
2128668

This condition may be caused by the nylon roller/slide block inside the left and/or right front roof panel latching handle becoming loose and causing the roller to move on the pin, creating the noise.

Important: For any latch handle replacement, use only P/N 19206591 (left) and P/N 19206592 (right). These current handles have a revised roller that was redesigned so it does not roll, but now slides across the latch receiver. All 2009-2013 removable roofs (painted and transparent) have the new handle design. **Handles should not be changed for vehicles built after the beginning of production for the 2009 model year.**

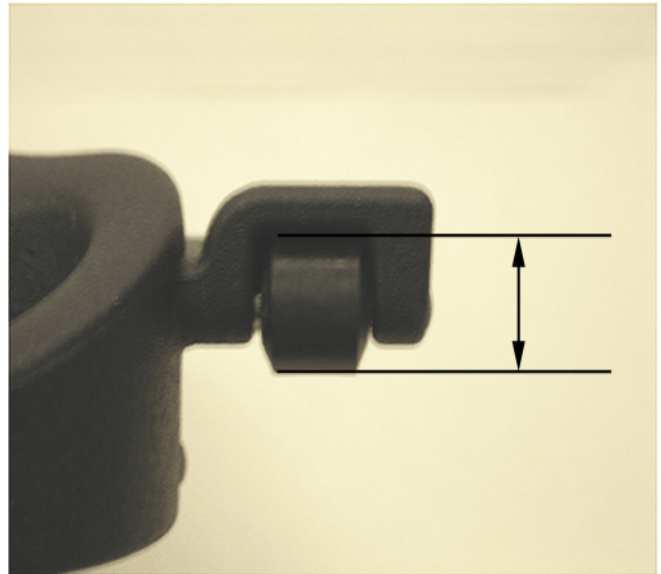
2236147

- If the roller is round and will spin on its axis (as shown above), they are early design handles and should be replaced. Replace the left and right front lift off roof panel handles with the current handle design parts noted previously, **and include the lubrication steps below.** Refer to Roof Lift Off Panel Front Latch Handle Replacement in SI.

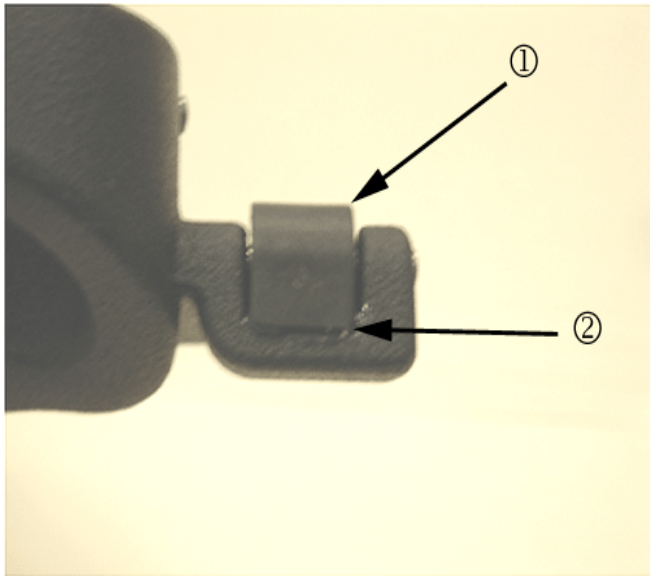
2236148

- If the roller is rounder on the contact side (1), and is flat and secured on the latch side (2), they are current design and DO NOT need replacement.

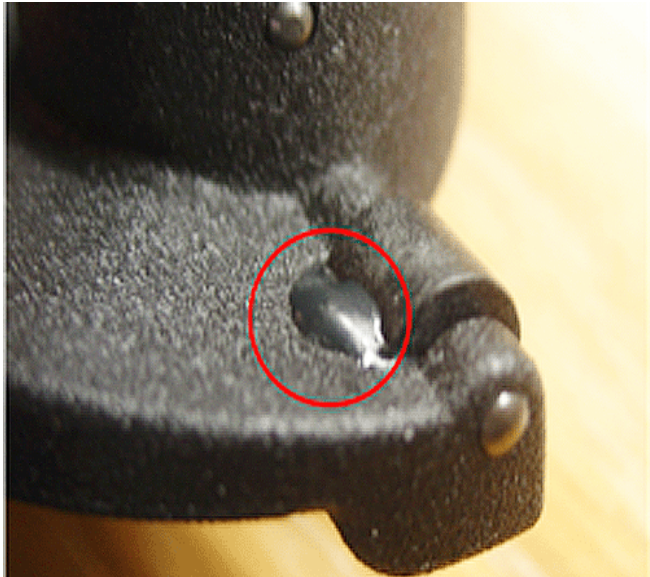
2537153

Important: Before proceeding with the lubrication, inspect the roller area for any excessive glue (as shown in the graphic above). If found, remove the excess glue with a sharp knife.

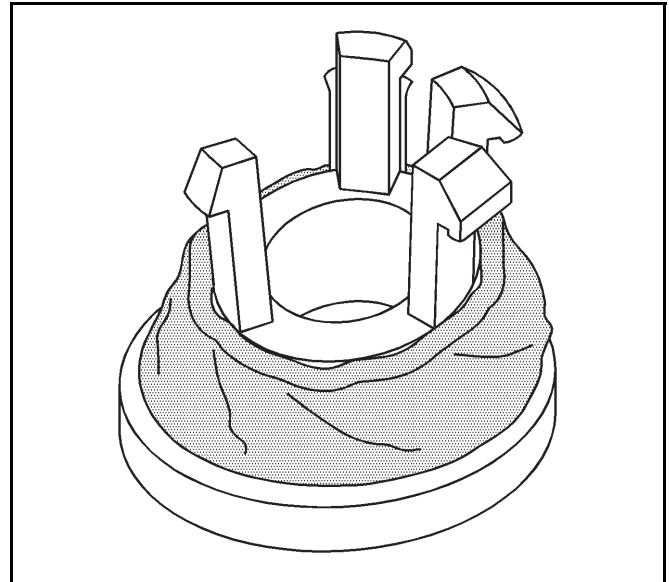
1935499

- 3.2. Once removed, inspect each insert (1) to verify the cones are not cracked or broken.

Note: The flocking is designed to insulate the cone when roof movement occurs.

- 3.3. Also verify that the inserts have an 8 mm (0.31 in) wide wrap of flocking tape toward the top of the cone, as shown above. If the flocking tape is worn or is missing, repair following the latest version of Corporate Bulletin Number 05-08-59-003.

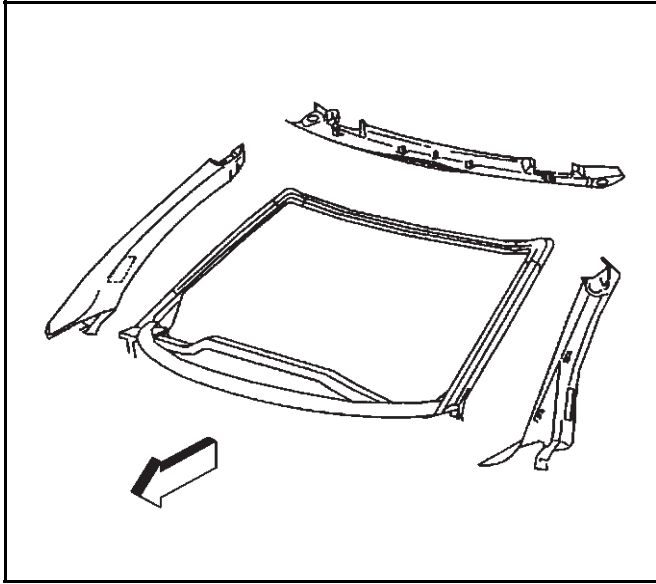
71178

The windshield side garnish moldings may be causing the noise.

The windshield upper garnish molding guides or the windshield header wiring harness may be causing the noise.

1. Remove the upper and both side windshield garnish moldings. Refer to Windshield Upper Garnish Molding Replacement in SI.
2. Follow the latest version of Corporate Bulletin Number 05-08-59-003 to add flocking tape to the "A" pillar garnish moldings.
