6F50/6F55 TRANSMISSION—SLIP/NEUTRAL OUT—
5TH GEAR START FROM STOP—BACKUP CAMERA
ON IN DRIVE—BUILT 3/13/2009-6/30/2010

TSB 13-5-27

This article supersedes TSB 13-4-2 to update Service Procedure

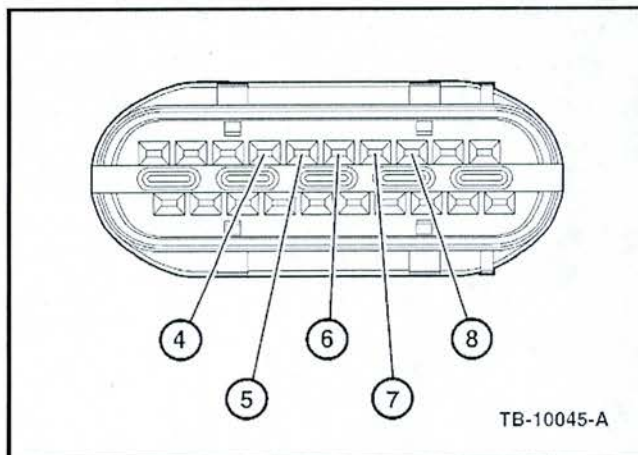
Figure 1 - Article 13-5-27

1. With brakes applied, engine off, key on, move the shifter to low gear (L or M) position.
2. Turn key off.
3. Disconnect connector C168 from the transmission.
4. Measure the resistance between the transmission connector pins:
 - 8 and 4
 - 8 and 5
 - 8 and 6
 - 8 and 7
 - a. The top row of the transmission's pins are numbered 1-10 from left to right. (Figure 1)

- b. If any of the four measurements are above 5 Ohms, proceed to Step 5.
- c. If all measurements are within specification, this article does not apply. Refer to the appropriate Workshop Manual (WSM) Section for diagnosis and repair.
5. Replace the TR sensor. Refer to the WSM, Section 307-01.
 - a. Use only essential special service tool (ESST) 307-696 to remove the retaining pin that holds the TR sensor in the transmission case.
 - b. Attach ESST 307-696 to the transmission case with two (2) pan bolts.
 - c. Slide the cylinder over the head of the retaining pin and tighten the nut on the threaded shaft to pull the cylinder up and retaining pin out of the transmission case. (Figure 2)
