CLUNK OR POP-TYPE NOISE AND/OR BUMP FELT FROM FLOOR PAN WHILE TURNING LEFT OR RIGHT—BUILT ON OR BEFORE 5/1/2012	TSB 13-6-7
--	-------------------

FORD:

2008-2012 F-Super Duty

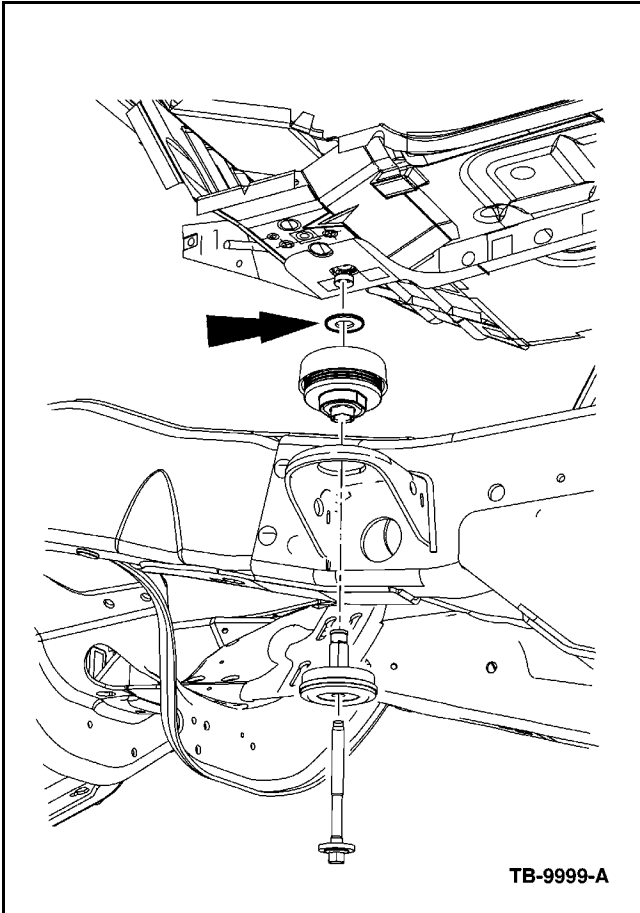
Figure 1 - Article 13-6-7

Some 2008-2012 F-Super Duty vehicles built on or before 5/1/2012 may exhibit a pop or clunk noise heard/felt under floor pan when turning, and may be more noticeable when cold.

- a. Yes - proceed to Step 4.
 - b. No - this article does not apply. Refer to (WSM), Section 100-04 for normal diagnostics.
4. Determine vehicle model year and built date.
 - a. 2008-2010 vehicles proceed to Step 5.
 - b. 2011 and 2012 vehicles built on or before 05/01/2012 proceed to Step 13.
 5. Loosen all body support mount bolts from the affected side except the front end sheet mount located behind the front bumper.
 6. Raise vehicle cab slightly approximately 25 mm (1").
 7. Remove the number 1 body support mount(s) on the affected side of the vehicle only. Refer to WSM, Section 502-02.
 8. Use a wire wheel to clean all threadlock material from the threads of the bolts.
 9. Install a shim between the floor pan and number 1 upper body support mount that exhibits the noise. (Figure 1)

10. Lower vehicle cab.
11. Apply Motorcraft® Threadlock and Sealer to the threads of the body support mount bolts.
12. Reinstall the body support mount bolts number 2, 3 and 4 and torque to 103 N•m (76 lb-ft). Refer to WSM, Section 502-02.
13. Replace the No. 1 lower body support mount(s). Refer to (WSM) Section 502-02.
 - a. Apply Motorcraft® Threadlock and Sealer to the threads of all body support mount bolt(s).
