# Product Upgrade Bulletin 130702FRV

**YEAR(S)  
AFFECTED:**  
2014

**PRODUCT(S)  
AFFECTED:**  
American  
Heritage,  
American Eagle,  
American  
Tradition,  
manufactured  
through June 20,  
2013

**SUBJECTS:**  
Installing  
resistors on the  
multiplex system  
to correct  
dimmer module  
freeze-up

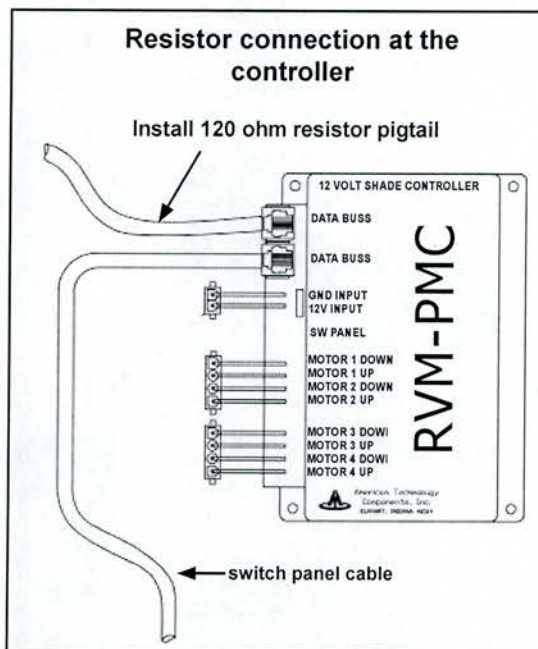
Figure 1

The dimmer module may cease to function, resulting in a loss of use of the bedroom and living room ceiling light switches. The installation of two resistors onto the multiplex system will correct this condition.

Note: For units equipped with Option #594 Power Shade Package, the resistors should be plugged into the data buss on the blind/shade controllers (Figure 1); for units not equipped with the option, plug the resistors into the switch panels (Figure 2).

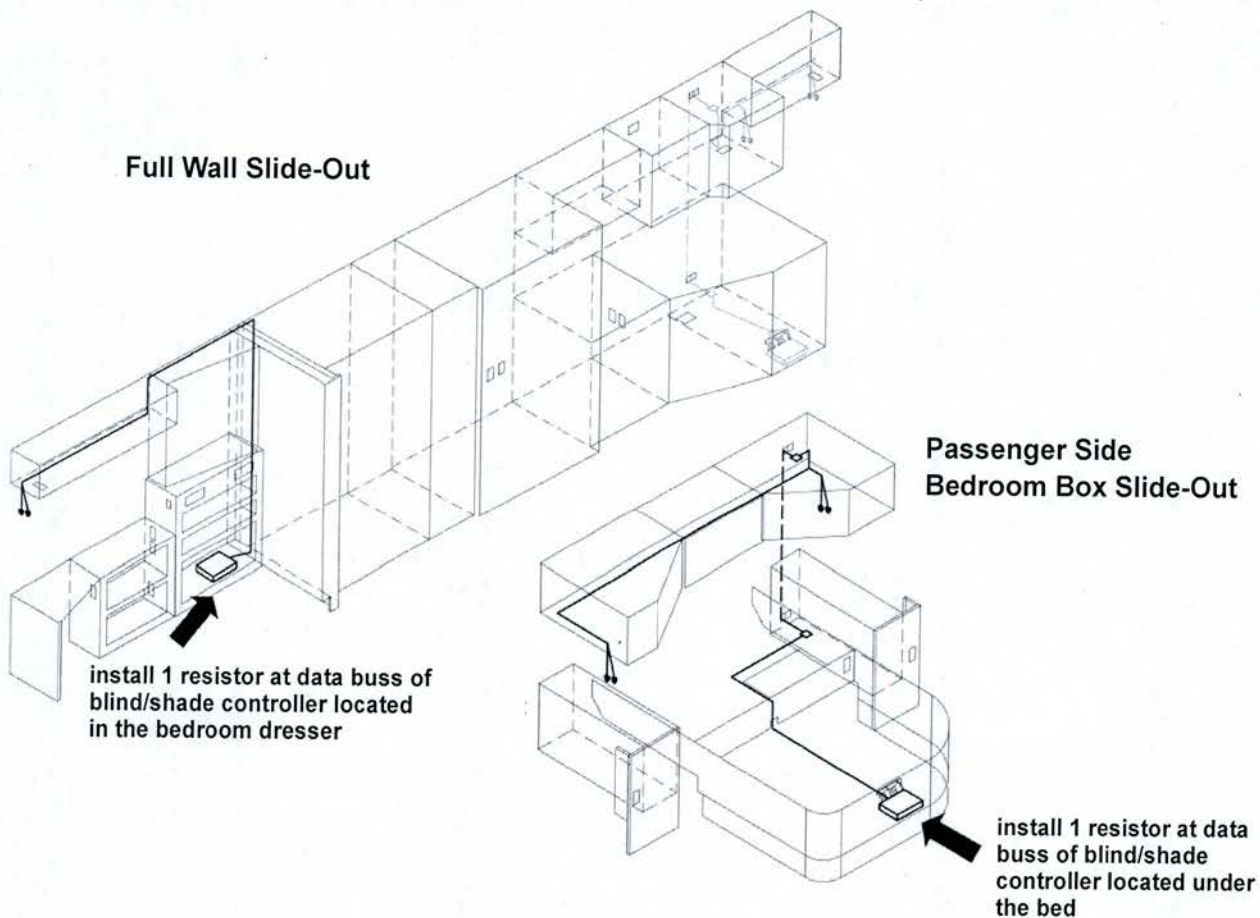
**Resistor installation locations for units equipped with optional power shade package**  
(Note - typical installation shown - actual floor plan varies according to model)

1. Reset the multiplex system by disconnecting the power wire and all communication wires connected to the dimmer module, then plug all wires back into the dimmer module.
2. Refer to the diagrams on page 2 indicating where to install two resistors on the multiplex system.

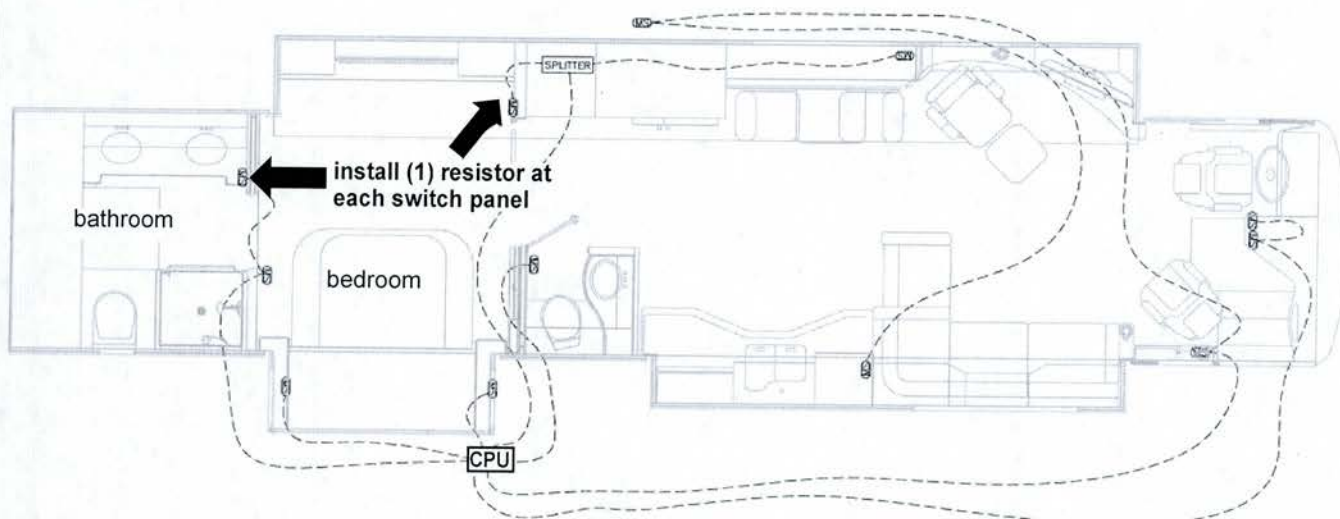
**Resistor installation locations for units not equipped with optional power shade package**  
Note - typical installation shown - actual floor plan varies according to model)
