SB-10053486-5842

SI B61 07 13
General Electrical Systems

Service Action: Repair Corrosion Protection on the Trunk B+ Connector

F30

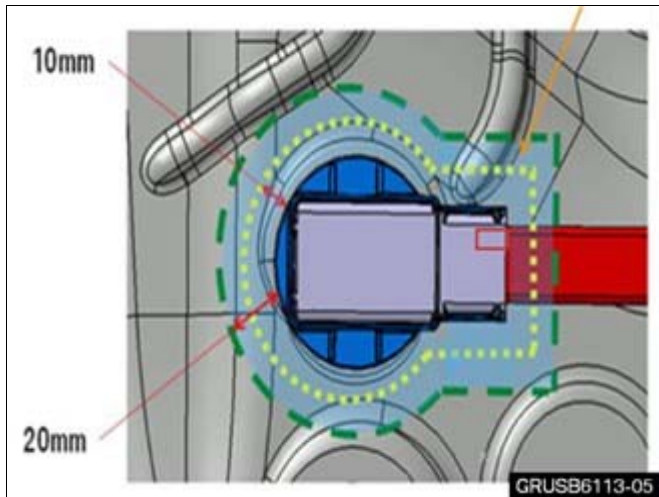
The corrosion protection on the outside of the trunk (back of rear right-hand wheel arch) around the battery positive connector is insufficient, and leads to corrosion on the body.

| | <ol style="list-style-type: none"> 2. Ensure the area around the connector is clean and dry in the marked area, as shown in the illustration. |

Coat the area around the positive battery cable connection with underbody protection (cavity protection spray).
