SB-10053486-9938

SI B61 07 13
General Electrical Systems

Service Action: Repair Corrosion Protection on the Trunk B+ Connector

F30

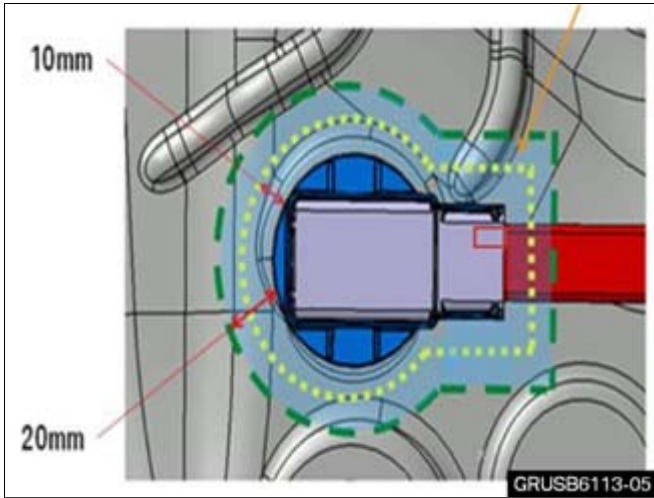
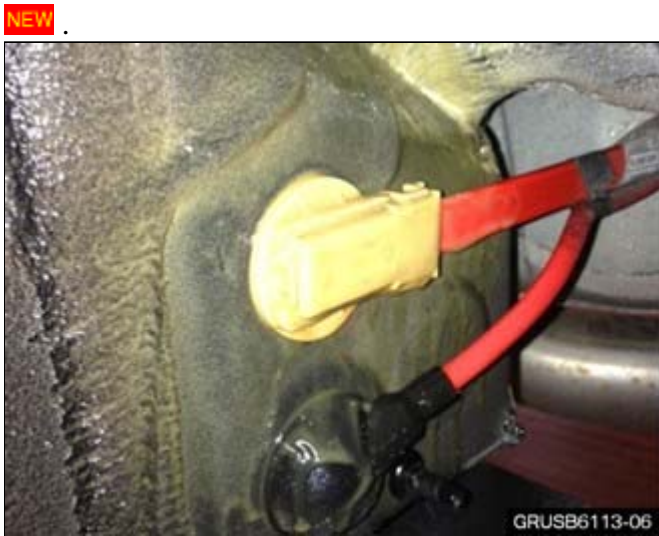
The corrosion protection on the outside of the trunk (back of rear right-hand wheel arch) around the battery positive connector is insufficient, and leads to corrosion on the body.

<ol style="list-style-type: none"> 2. Ensure the area around the connector is clean and dry in the
--	---

marked area, as shown in the illustration.

Coat the area around the positive battery cable connection with underbody protection (cavity protection spray).

3. Apply the underbody corrosion protection (cavity protection spray) over and around the connector, as shown. The connector should be completely sealed.
4. Reinstall the partially removed wheel arch cover.
