BULLETIN NUMBER:  
**IB13-K-001**

## AUTOMATIC TRANSMISSION FILTER CRACKING OR SPLITTING

- 2012-2013MY Isuzu N-Series  
Equipped with 6L90E 6-Speed Automatic Transmissions

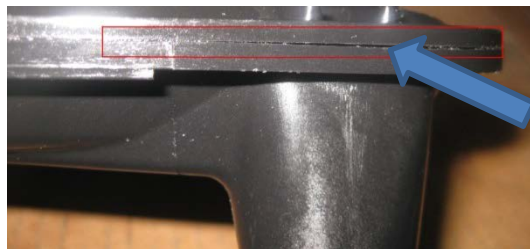
**Figure 3 – Small Filter Split**

Testing and analysis of transmissions found with split or damaged filters have shown that this condition may be caused by a damaged pump, which can send a high pressure spike of fluid down the filter neck on a cold start, resulting in the filter body cracking or the filter seam splitting.

After confirming a cracked or split filter, technicians are to contact the IQC per bulletin IB09-X-001E. Follow the instructions provided from the IQC to complete the repair.
