**SB-10053498-1066**

SI B63 05 12  
Lights

**Tail Lamp Is Loose in the Trunk Lid**

F30

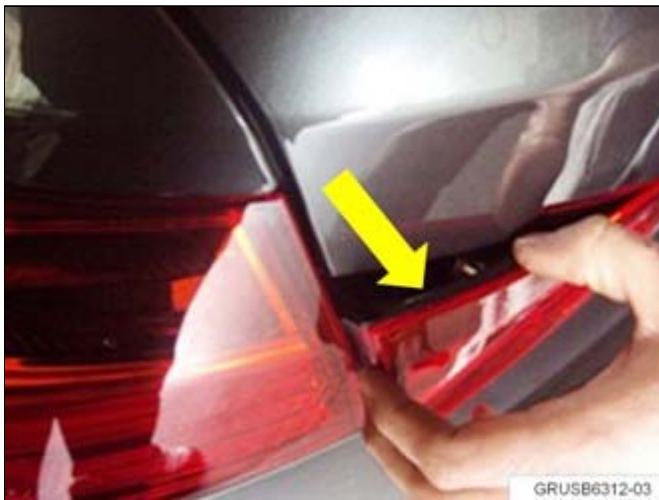
The customer may notice the tail lamp is either loose or protruding outward from the trunk lid.

The tail lamp is not attached to the trunk lid properly.

1. Check both rear trunk lid tail lamps for looseness or protrusion. If improper tail lamp fitment is noted, remove both left and right tail lamps. Refer to ISTA Repair Instruction 63 21 240 and 63 21 245.

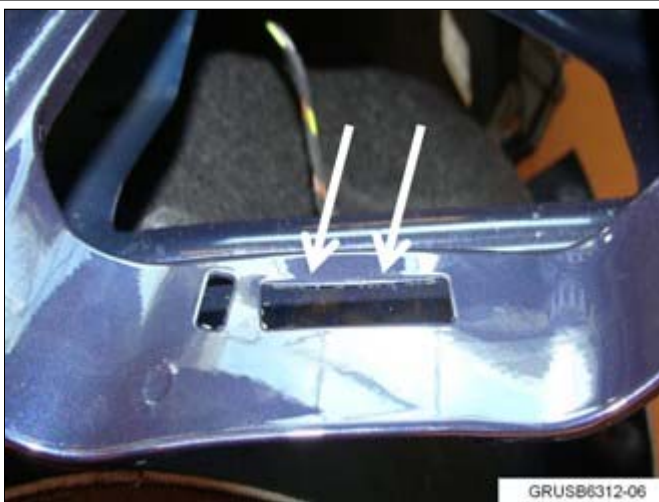
4. Before installing the taillight, inspect the trunk lid where the taillight was removed. Check the sheet metal area where the taillight hook is inserted. In this case, you can see by the reflection (white arrows) the sheet metal has been bent down by the hook during installation. This will not allow the hook to fully seat properly under the metal lip and needs to be corrected.
