## Technical product information

<b>Topic</b>	Gear range selector inoperative
<b>Market area</b>	Worldwide Bentley (1WBE)
<b>Brand</b>	Bentley
<b>Transaction No.</b>	2033480/1
<b>Level</b>	EH
<b>Status</b>	Approval
<b>Release date</b>

Transaction No.: 2033480/1

Gear range selector inoperative

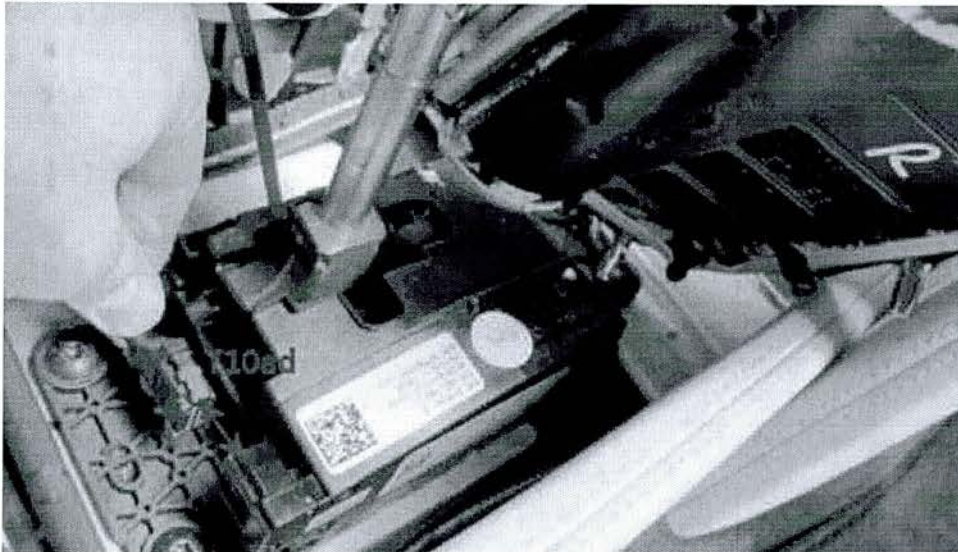
Figure 1

A software anomaly has been identified that can result in the transmission control module losing communication with gear selector electronics at the time of ignition switch on. When this is the case the driver will not be able to select a gear from Park and communication with this module via the Bentley diagnostic tool will not be possible.

To disconnect/reconnect the gear selector electronics disconnect the 10 way connector (connector

T10ad in current flow diagrams) at the gear selector assembly (see Figure 1)

2. Pull the switch pack upwards from the rear edge
3. Disconnect the harness connector arrowed – from the rear of the switch pack  
**Note:** as long as the ribbon cable is not strained it can remain connected for this operation
4. Disconnect and reconnect connector T10ad (see Figure 1)  
Communication should now be possible - Clear the event memory entries - Test the gear
