| | AUTOMATIC TRANSMISSION | 13-AT-015 |
| | AUGUST 2013 | Genesis Sedan (BH), Genesis Coupe (BK) and Equus (VI) |

SUBJECT: **AUTOMATIC TRANSAXLE (8-SPEED)
INHIBITOR SWITCH DTC P0705, P0706**

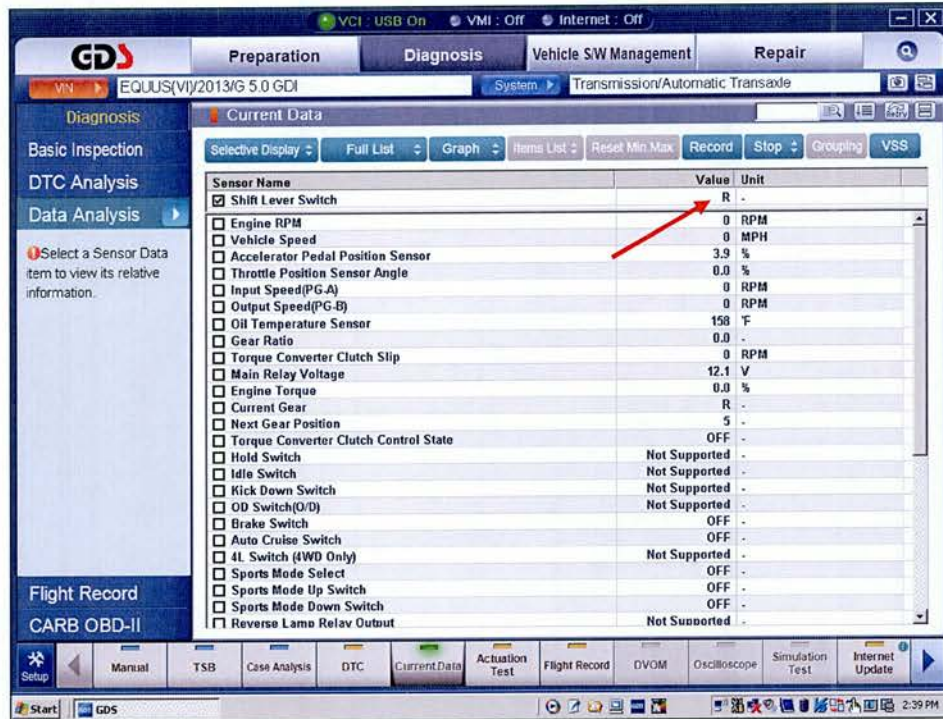
1. Turn the ignition key to the ON position or push the Start/Stop Button two times without depressing the brake pedal.
2. Using a GDS, check for DTC in the “Automatic Transaxle” menu. **Record the DTC and description.** Delete the DTC.
3. Select the following parameters. Move the shift lever through all gears and confirm the GDS shows P, R, N and D.
 - Vehicle and A/T menu.
 - “Current Data”
 - Shift Lever Switch.

4. If the Shift Lever Switch shows:
 - The correct shift lever position (P, R, N and D), the wiring **currently** has no open/short circuits. Go to Step 6.
 - Does not show the correct shift lever position, go to Step 5.
5. Visually check the wiring harness between the PCM and inhibitor switch for any damaged wires or open circuit/short circuit to ground. Check for any damaged pins or pin not fully inserted into the connector.
 - If damage exists, repair or replace the control wiring and drive the vehicle to confirm the repair.
 - If no damage or open/short circuit is found, go to Step 6.
