Authorized Field Change

AFC 13903

Subject: Inspection of Air Control Valve (ACV) Connector / Engine Harness Connection for proper plug orientation and corrosion.

Engine Family: MaxxForce[®] 11 and 13

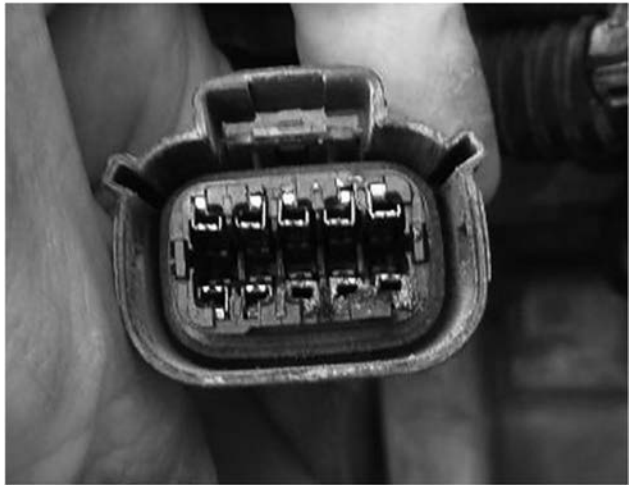
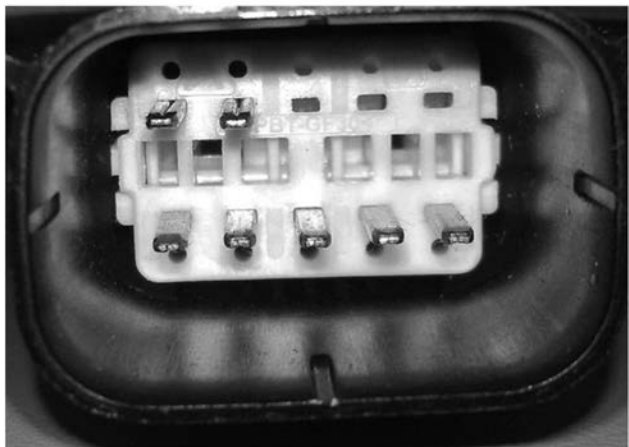
8. Inspect both sides of connector for corrosion (Figures 4 and 5).
 - a. If corrosion is present, proceed to Step 20 and finish labor operation A40-13903-3, install new ACV kit and higher level ACV kit.
 - b. If no corrosion is present, proceed to Step 9 and finish labor operation A40-13903-2, reverse cavity plugs.

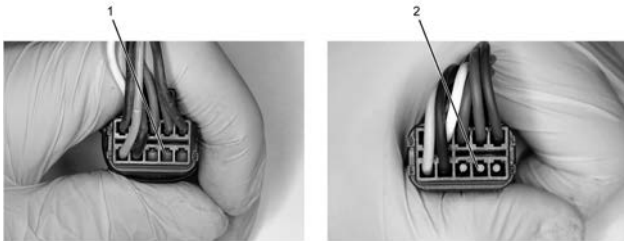
Figure 6. ACV Connector Plugs.

1. Incorrectly installed plugs
2. Correctly installed plugs

NOTE: Incorrectly installed plugs may cause corrosion due to moisture intrusion.

9. Inspect plugs in ACV connector to determine if they have been inserted backwards (Figure 6).
 - a. If plugs are installed correctly (Figure 6, Item 2), reconnect mating ends of connector, re-latch red lock button, and proceed to Step 52.
 - b. If installed incorrectly (Figure 6, Item 1), proceed to Step 10.
