SB-10053584-1434

SI B11 05 13
Engine

Turbocharger Coolant Return Pipe Leaking

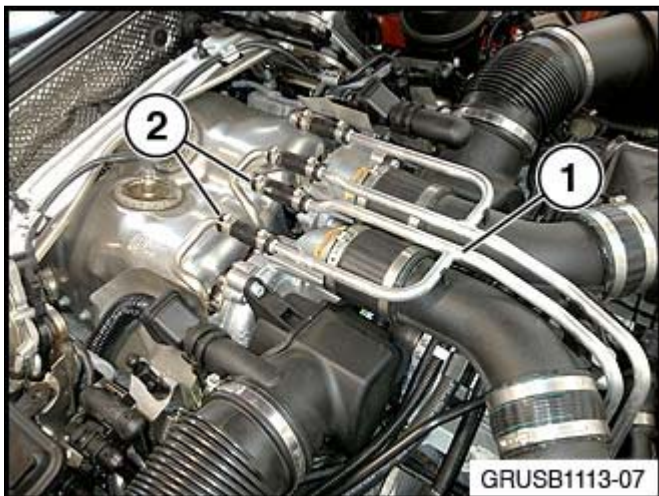
A Check Control message for low coolant level is displayed. There are traces of coolant leaking in the engine compartment at the turbochargers.

The auxiliary coolant pump for the turbochargers does not run during an MSA shutdown. Frequent MSA starts and stops could result in excessive temperatures in the cooling circuit of the turbochargers.

Verify the coolant leak is coming from the coolant return line of the turbochargers (1). Replace the line and clamps (2).

Reprogram the vehicle with ISTA/P 2.49.0 or higher. This latest programming will enable the auxiliary coolant pump to run during an MSA shutdown.
