SI B17 02 09  
Cooling Systems

### Oil Leak from Turbocharger Charge Air Hose

E70, E90 with M57Y diesel engine

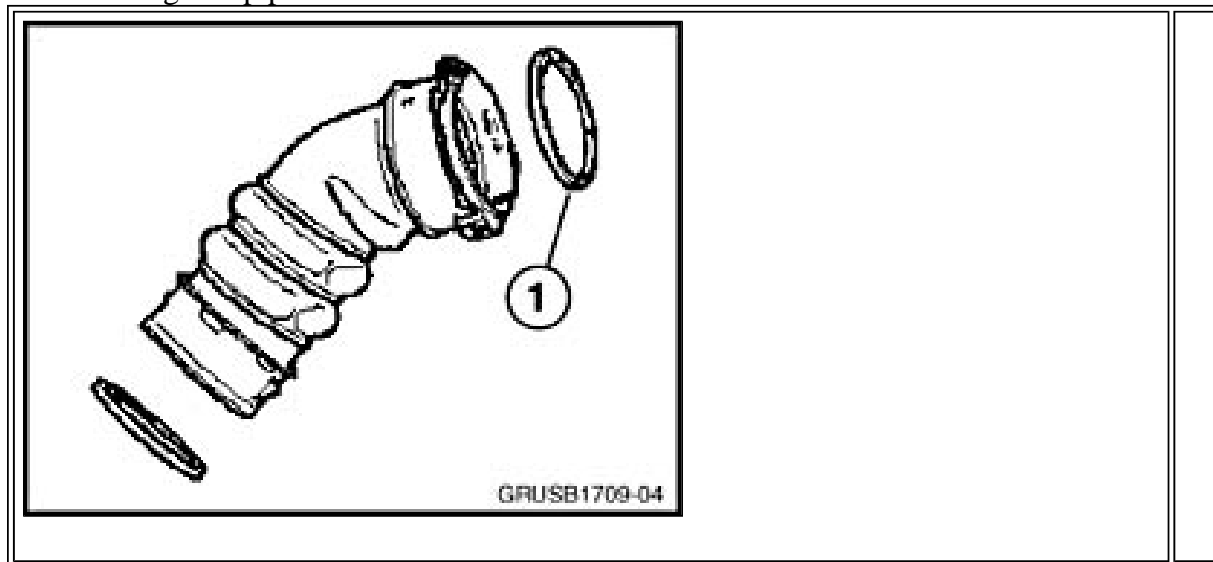
The molded seal in the charge air pipe may have been cut by debris abrasions, causing an external leak of air and oil in the charged air system of the turbocharger. An improved seal has been developed to correct this issue.

Remove the charge air pipe that connects the turbocharger to the intercooler. Thoroughly clean all mating surfaces and the charge air pipe.
