# Technical Service Bulletin

| SUBJECT: | | | No: <b>TSB-13-35-004</b> |
| <b>ACC/FCM/ASC WARNING LAMP ILLUMINATION:<br/>POSSIBLE DTCS STORED IN ASC – ECU</b> | | | DATE: <b>October, 2013</b> |
| | | | MODEL: <b>2014 Outlander</b> |

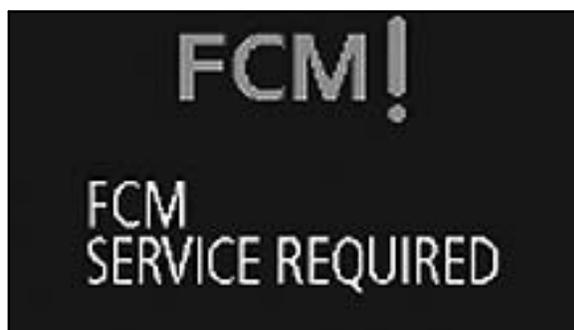
- (1) When starting to climb a grade immediately after descending a steep hill with the Adaptive Cruise Control (ACC) engaged, the following messages may be displayed on the MID.

- FCM SERVICE REQUIRED
- ACC SERVICE REQUIRED
- ASC SYSTEM SERVICE REQUIRED (with DTCS C1800, C1777)

The ECU determines this is abnormal acceleration and the system may enter “fail-safe” mode with ACC and FCM becoming inoperative.

This TSB instructs dealers to reprogram the ASC-ECU with new software to resolve mis-detections.

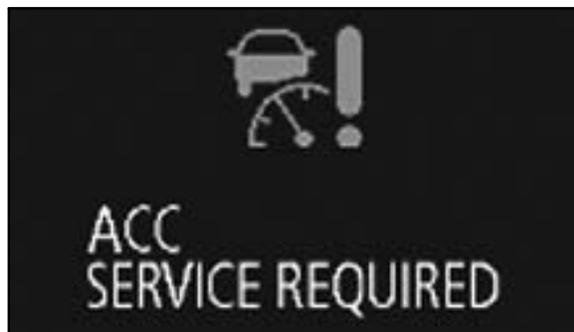
- (2) When driving in a lane with normal traffic flow, and an adjacent lane is jammed, FCM SERVICE REQUIRED, ACC SERVICE REQUIRED and ASC SYSTEM SERVICE REQUIRED may be displayed (with DTCS C1802, C1777).

The continued presence of objects creates continuous inputs to trigger FCM operation. The system determines this as an abnormal signal. The system may enter “fail-safe” with ACC and FCM becoming inoperative.

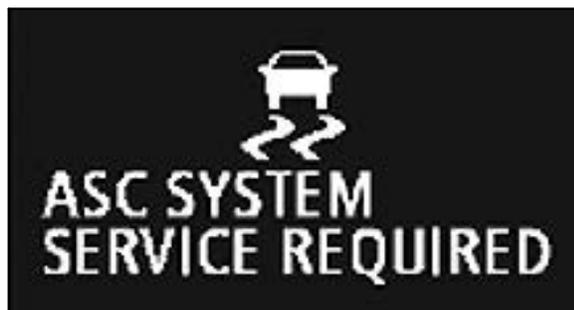
- (3) ASC SYSTEM SERVICE REQUIRED may be displayed without DTCS.
