NUMBER: 08-069-13

Cooling Fan Will Not Turn On

2013-2014 (JK) Wrangler

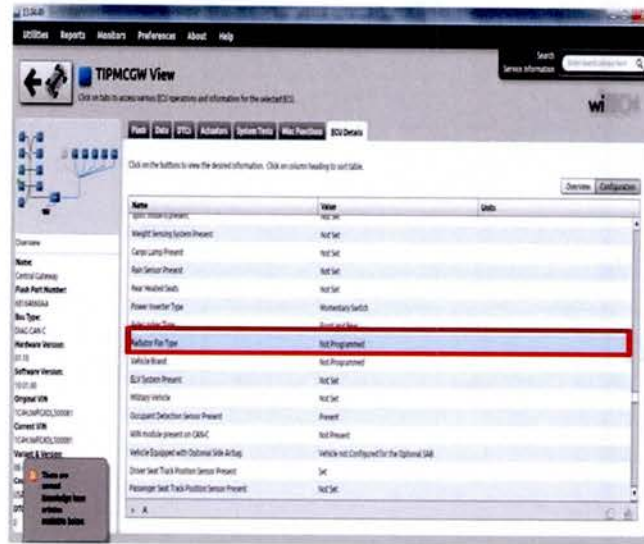
Fig. 1 Vehicle Not Properly Configured For Fan Type

1 - If the vehicle was properly configured, the value will read "PWM - 10Hz".

1. Using wiTECH, reconfigure the vehicle. This routine is available under the 'Diagnostic Procedures' tab found on the home, 'Vehicle View', page of wiTECH.
2. Using wiTECH clear any DTCs which may have been set during the reconfiguration.
