GROUP Transmission	MODEL 2011-2012MY Sportage (SL)
	NUMBER 048	DATE September 2013
TECHNICAL SERVICE BULLETIN		
SUBJECT: COMBINED TSB/SERVICE ACTION: SHIFT KNOB TRIM RING REPLACEMENT PROCEDURE (SA147)

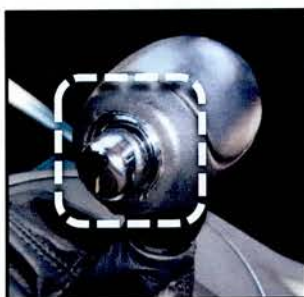
Shift Knob Trim Ring Assembly

This bulletin provides the procedure to replace the shift knob trim ring on some Sportage (SL) vehicles, produced from May 6, 2010 to June 8, 2011 (2011MY) and from May 17, 2011 to March 23, 2012 (2012MY), which may exhibit a difficult to depress A/T shift knob button. This condition may be caused by decreased clearance between the shift button and the trim ring. Replace the affected trim ring to resolve the concern by following the Service Procedure outlined in this bulletin. Before conducting the procedure, verify the vehicle is included in the list of affected VINs.
