Service Bulletin

Subject: LACK OF POWER / WRENCH LIGHT COMES ON WITH DTCs P0123 / P0222	Bulletin No: 01-017/13
	Last Issued: 07/02/2013

2011-2013 CX-9 with VINs lower than JM3TB*****419830 (produced May 1, 2013)

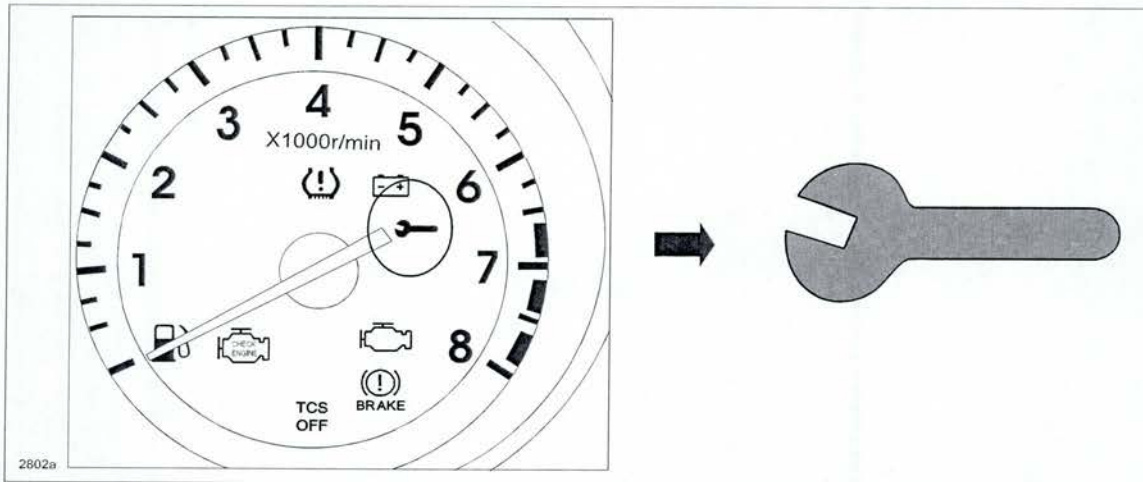
Some vehicles may experience a lack of power and the wrench light comes on with DTCs P0123 / P0222 stored in memory.

Wrench Light: Powertrain Malfunction / Reduced Power Warning Light

- DTC: P0123:00 TP sensor No.1 circuit high input.
- DTC: P0222:00 TP sensor No. 2 circuit low input.

To eliminate this concern, the emissions harness has been improved.
