Service Bulletin No. 398B

<i>MODEL</i>	D Series	<i>TYPE</i>	Field Change Program	<i>SECTION/GROUP</i>	7 – Electrical	<i>DATE</i>	Aug. 15, 2013
<i>SUBJECT</i>	ACTIA POWER MANAGEMENT MODULE 1 / OUTPUT 29						
<i>CONDITIONS</i>

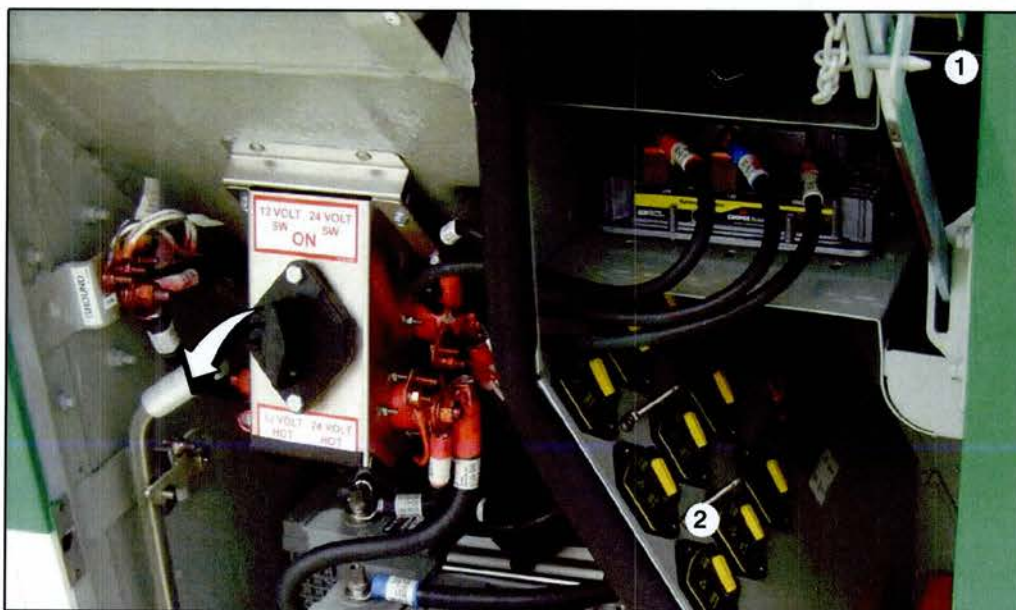
Figure 2. Battery compartment.

ITEM	DESCRIPTION
1	Install the positive lock pin in the hole
2	Circuit breakers

2. Turn the main battery disconnect switch to the ON position.
3. Using the Amps Reflash program, upload the coach program. Save it on the laptop be downloaded at a later step in this procedure.
4. Open the battery compartment door and secure in the open position by installing the positive lock pin in the hole as shown in Figure 2.
5. Turn the main battery disconnect switch to the OFF position. Turn all circuit breakers to the OFF position.
