GROUP 11 – Engine

FRAYED STITCHING ON THE OUTER LAYER OF THE ACCESSORY DRIVE BELT — 2013-14 Outlander Sport. MMNA has received comments about “frayed” stitching on the outer layer of the accessory drive belt. This stitching is not structural. It is used in belt production to hold the outer layer of the belt together until it is fused to the rest of the belt. Frayed stitching has no affect on belt durability once production is complete.

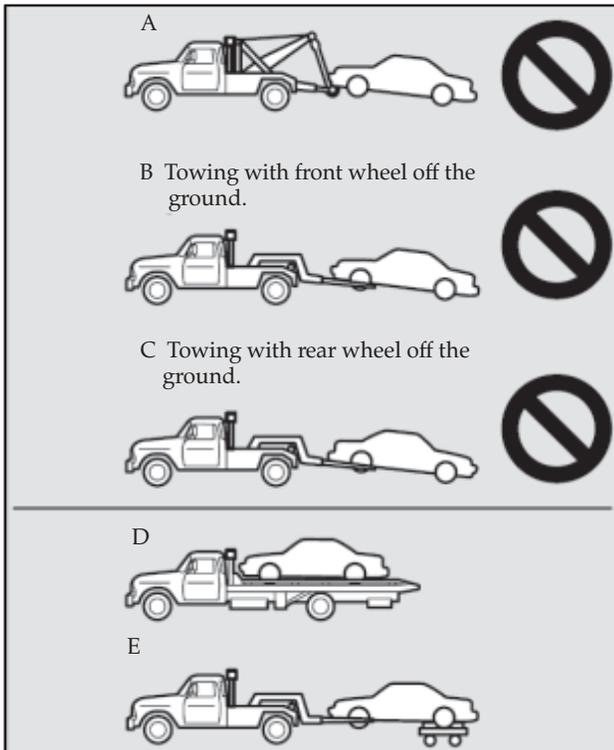
are towed incorrectly (single axle tow, A, B, C below) the driveline will be damaged. Damage from improper towing is not covered by warranty.

AWD models must be transported on a “flatbed” tow truck (D, above) or, at minimum, by using a “tow-dolly” on the non-lifted axle of the vehicle (E, above).

- This vehicle must not be towed by a tow truck using sling lift type equipment (Type A) as illustrated. Using a sling lift will damage the bumper and front end.
- Do not tow all-wheel drive vehicles with the front or rear wheels on the ground (Type B or Type C) as illustrated. This could result in the driving system damage or vehicle may jump at the carriage. If you tow all-wheel drive vehicles, use Type D or Type E equipment.

If you suspect that a drive train issue may be due to improper towing, consult with your DPSM before beginning any repairs.
 Damage to drivetrain components caused by improper towing is not covered under warranty.
