Subject: DRIVER SIDE SEATBACK RECLINING POSITION CHANGES BY ITSELF WHEN CUSTOMER EXITS THE VEHICLE	Bulletin No: 09-020/13
	Last Issued: 07/11/2013

2013-2014 CX-5 with VINs lower than JM3 KE***** 338025 (produced April 1, 2013)

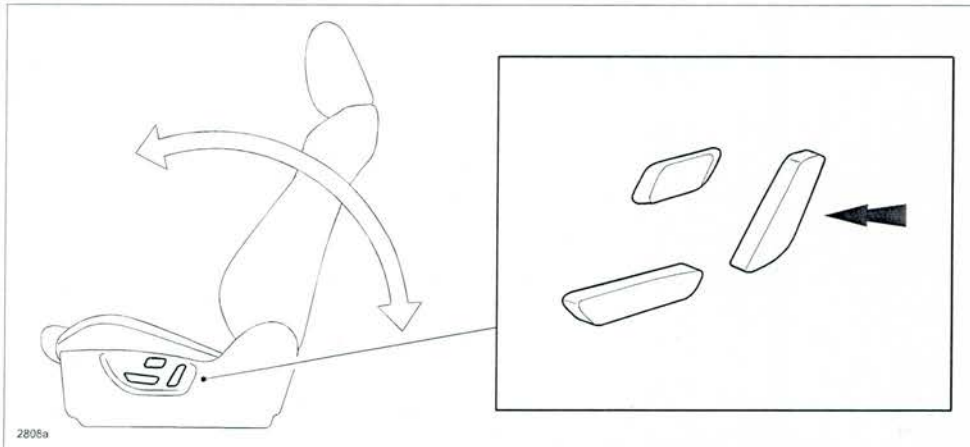
Some customers may complain that the driver side seatback reclining position seems to change by itself. This may be caused unknowingly by the customer when they exit the vehicle. The customer's leg may be contacting the recliner switch and changing the seatback reclining position.

The configuration of the recliner switch has been changed to eliminate this concern.

1. Verify the customer concern.
2. Replace the recliner switch with a modified new part according to the instructions on MS3 online or the Workshop Manual (section 09-13 FRONT SEAT SIDE COVER REMOVAL/INSTALLATION).
3. Verify the repair.
