# Service Bulletin

**Subject:** Transmission Fluid Leak at Auxiliary Pump Seal

**Models:** 2014 Chevrolet Malibu  
Equipped with 6T40 Automatic Transmission (RPO MNH)

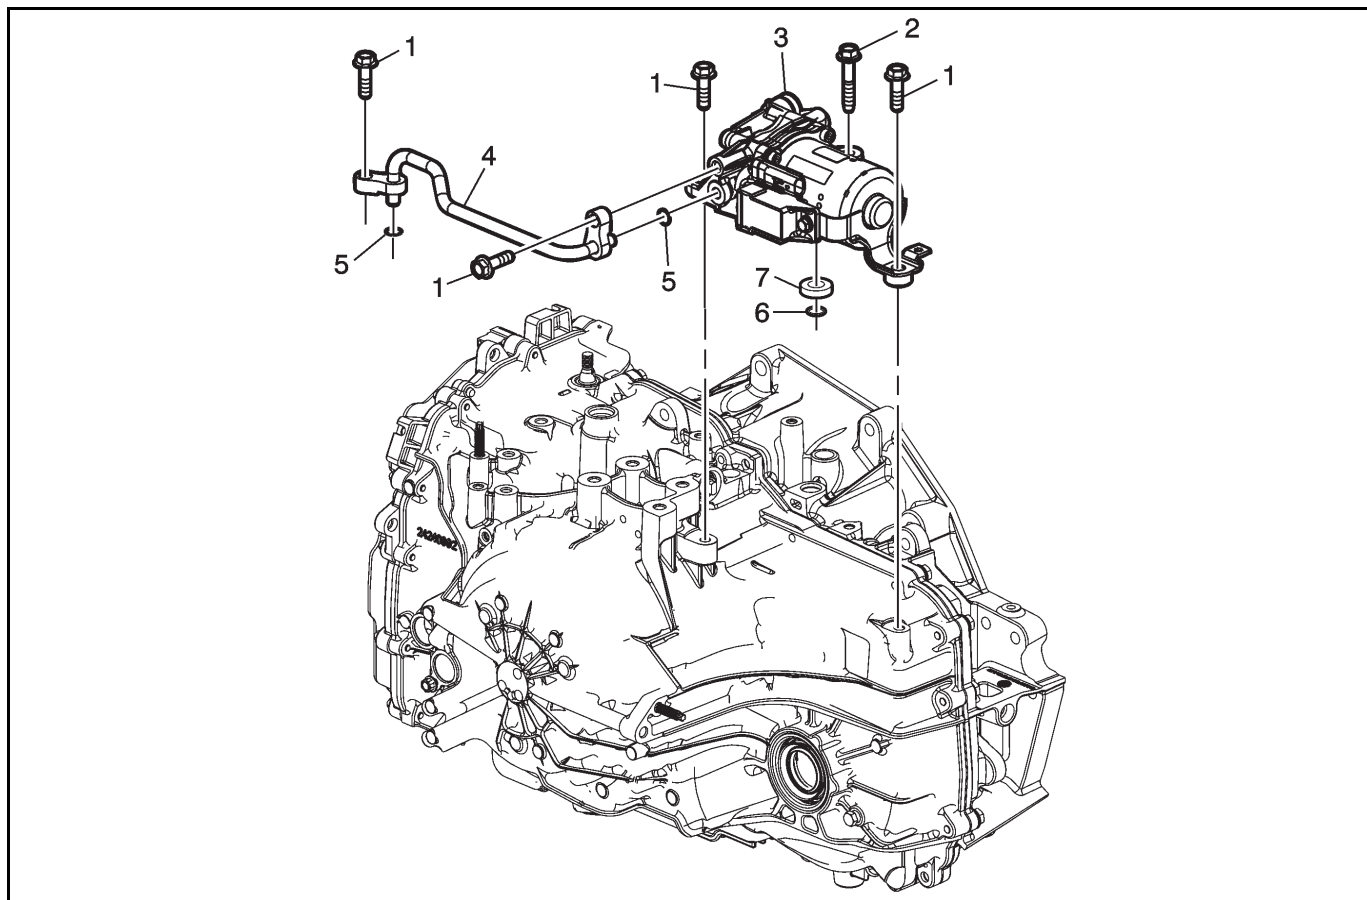
2552766

Investigation of the leak may show that the fluid is leaking on top of the transmission at the auxiliary fluid pump seal (6).

If leak diagnosis determines that the leak source is the auxiliary fluid pump seal, it should be replaced.

**Important:** To prevent damage to the replacement seal, be sure to lubricate the seal with transmission fluid before installing the auxiliary pump.

**Important:** The auxiliary pump seal should be checked for leaks after installation using the following steps.

1. Start the engine.
2. With the transmission in Park and the park brake applied, raise the engine speed to 4,000 RPM for at least 30 seconds.
3. After 30 seconds, shut off the engine and inspect the transmission for leaks in the area of the auxiliary pump.
