Program Bulletin

CUSTOMER SATISFACTION PROGRAM

SUBJECT: Front Strut - Noise

MODELS: 2012-2013 Chevrolet Colorado

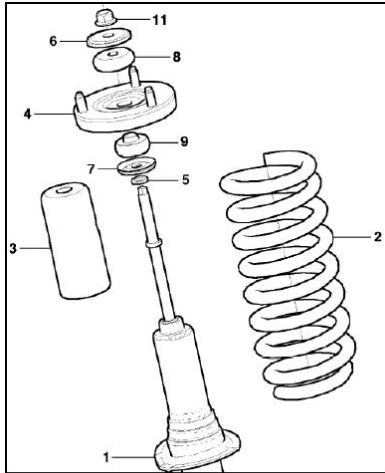
Figure 1

4. Remove the top mount plate. Ensure SI procedures are followed as the spring is under tension and injury could occur if incorrectly disassembled.
5. Refer to figure 1 - the lower bush (9) will be replaced as well as the spring seat isolator (not shown in figure 1). In addition, inspect the top mount bracket (4), cup washer (7), upper bush (8), and shocker absorber rod (1) for damage. Follow these guidelines to determine if these parts should be replaced:
 - Place a straight edge along the shocker absorber rod as shown in figure 4.
 - Measure the depth of wear on the shaft. If the wear is greater than 1mm, replace the shock absorber.
 - Inspect the steel washer (silver) that is pressed into the centre of the top mount bracket. If the washer has worn through to the black steel mount bracket, then replace the top mount bracket, refer figure 5.

3. Before removing the top mount bracket (refer figure 1, item 4), place alignment marks on the top mount bracket and spring using the outboard mounting bolt on the strut top bracket as a reference. Mark the bottom of the spring to shocker absorber as well. These marks should all be aligned as shown in figure 2 and 3.
