Service Bulletin

**SUBJECT: Service Update for Inventory Vehicles Only
Rear Glass Water Leak
Expires September 30, 2014**

MODELS: 2014 Chevrolet Cruze

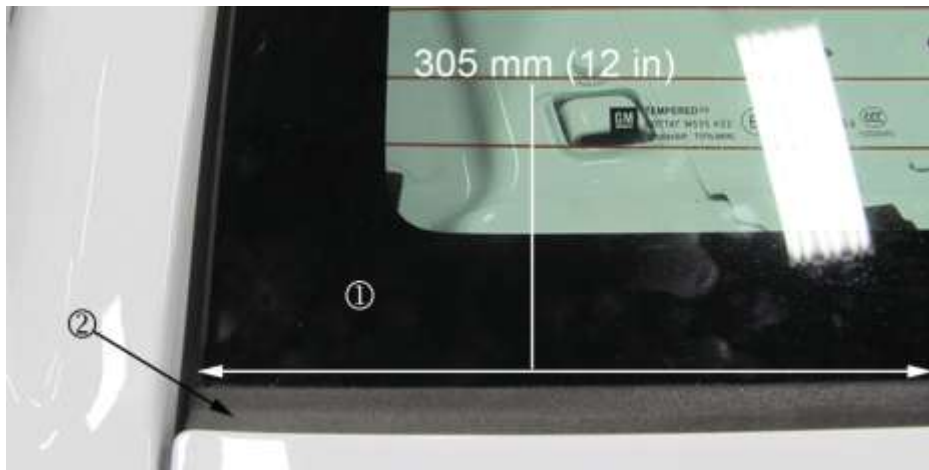
3613309

Note: Some vehicles may have a urethane sealing issue in the area shown in the photograph. The area of concern is a 305 mm (12 in) section of the rear window glass that begins at the left (driver side) lower corner and ends near the CHMSL. The urethane sealing issue, if present, may allow water to enter the trunk. Look for evidence of a water leak in the trunk.

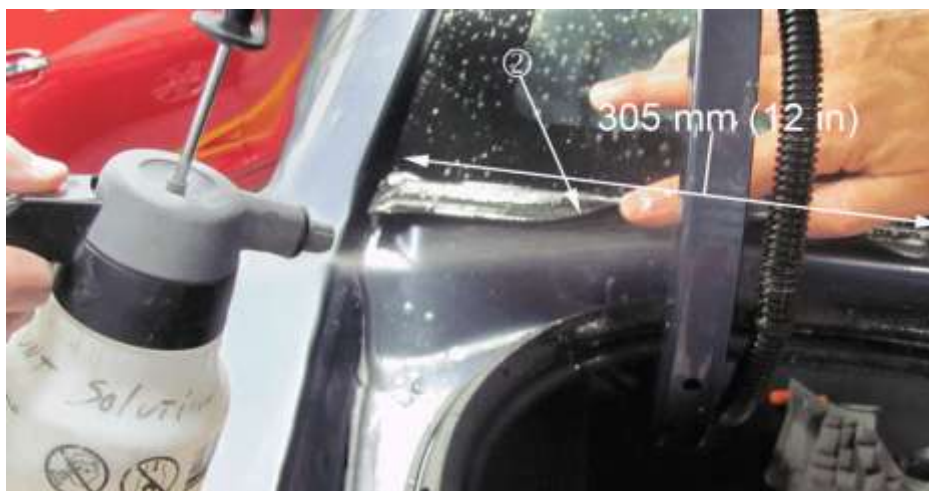
3613311

1. Locate the rear left (driver side) window glass (1) and rear window water deflector (2).

2. Apply a soap and water solution under the water deflector in the 305 mm (12 in) section of the rear glass shown in the photograph.

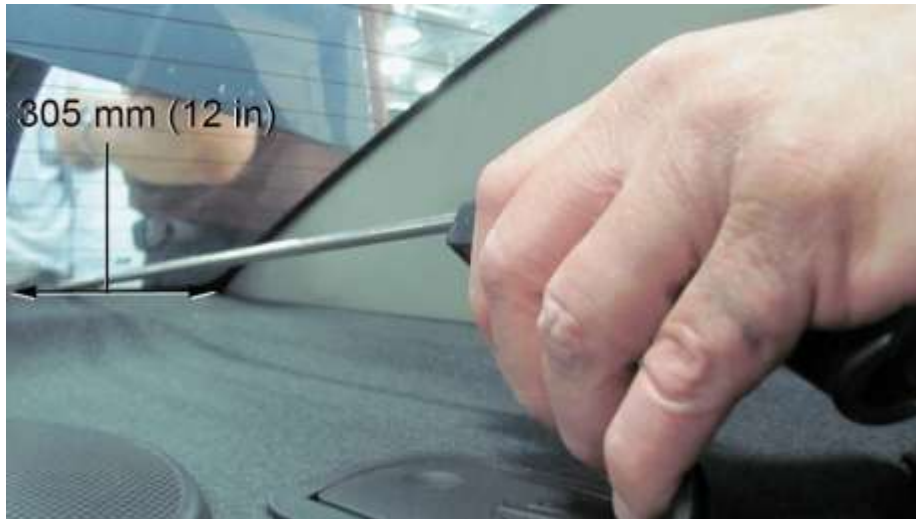
3613312

Note: Have a second technician sit in the rear seat of the vehicle to apply air pressure to the rear glass during and after step 2. Use a small air nozzle to apply compressed air to the inspection area. Refer to photograph.

3. Apply compressed air to the bottom edge of the rear glass in the inspection area indicated in the photograph.
4. Determine if a water leak is present. Examine the soap and water solution to determine if a water leak is present.
 - If a water leak is NOT present, no further action is required.
 - If a water leak is present, remove and replace the rear window glass. Refer to *Rear Window Replacement* in SI.
