Technical Service Bulletin

80 Coolant loss from coolant valve, engine warning light on, "Limp Home" mode active

80 13 04 2033806/3 August 9, 2013. Supersedes Technical Service Bulletin Group 80 number 13-03 dated May 13, 2013 for reasons listed below.

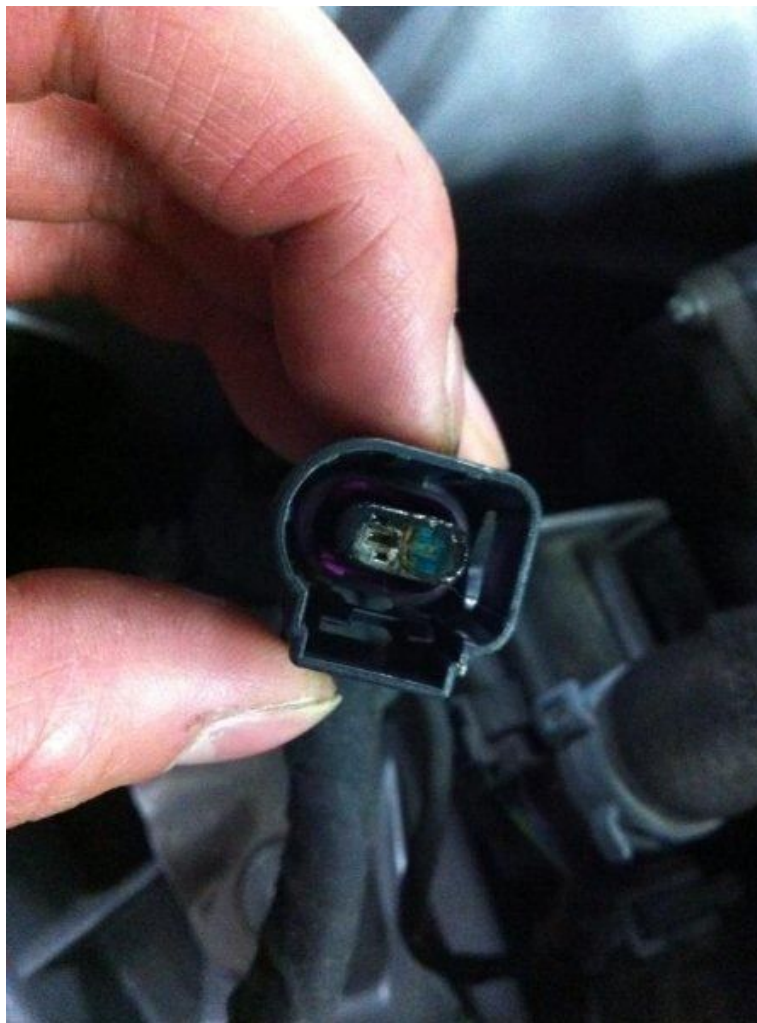
The connectors, wiring harness, and/or connected control units may have been damaged from exposure to coolant (Figure 2).

Figure 2. Corrosion formation on the connector pins.

Tip: Check the connectors, wiring harness, and connected control units for coolant damage. Perform repairs as necessary.
