Technical Service Bulletin

97 Multiple warning lights illuminated; communication error DTCs

97 13 40 2034945/2 November 26, 2013. Supersedes Technical Service Bulletin Group 97 number 13-37 dated August 8, 2013 for reasons listed below.

Model(s)	Year	VIN Range	Vehicle-Specific Equipment
Q7	2010 - 2014	All	Not Applicable

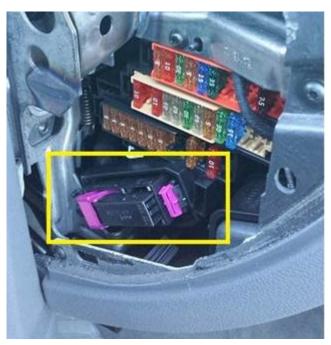
There is sporadic data disruption on the CAN bus wiring behind the dashboard, between the left (T46a) and right (T46b) 46-pin CAN disconnect plugs.

Figure 1. T46a CAN disconnect plug, left dashboard.

- 1. Upload GFF paperless log showing communication DTCs as described in the complaint.
- 2. Overlay new CAN twisted pair wiring behind the dashboard, between the two 46-pin CAN disconnect plugs (T46a/1H <-> T46b/1H and T46a/1L <-> T46b/1L) (Figure 1 and Figure 2).

3. Replace the terminals with the VAS1978B repair kit.

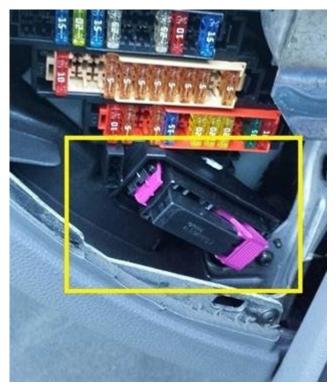
Figure 2. T46b CAN disconnect plug, right dashboard.
