# Service Bulletin

**Subject:** Waterleak from Headliner at A/C Outlet Vents or Dome Light Above 2nd or 3rd Row Seating Positions

**Models:** 2012-2014 Buick Enclave  
2012-2014 Chevrolet Traverse  
2012-2014 GMC Acadia

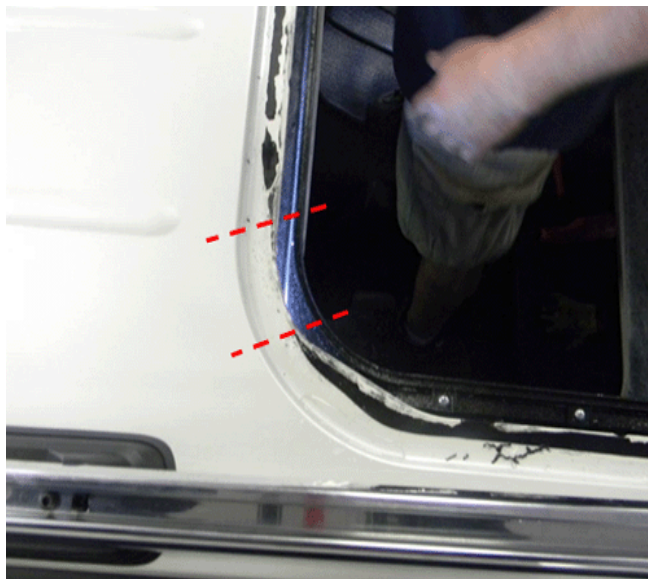
To properly verify that the leak is from the sunroof rear stationary glass, use a soapy solution and compressed air. The more common areas where leaks may be found is at the center rear edge of the glass, or in the front or rear corners of the glass. Several examples are shown in the graphics below.

If a leak is confirmed, remove and reseal the glass. Refer to Roof Stationary Window Replacement in SI.
