Emissions Service Action

Code: 23M1

**Subject: 2009 - 2012 Volkswagen Touareg 3.0L TDI
Differential Pressure Sensor/ECM Software Update**

August 06, 2013

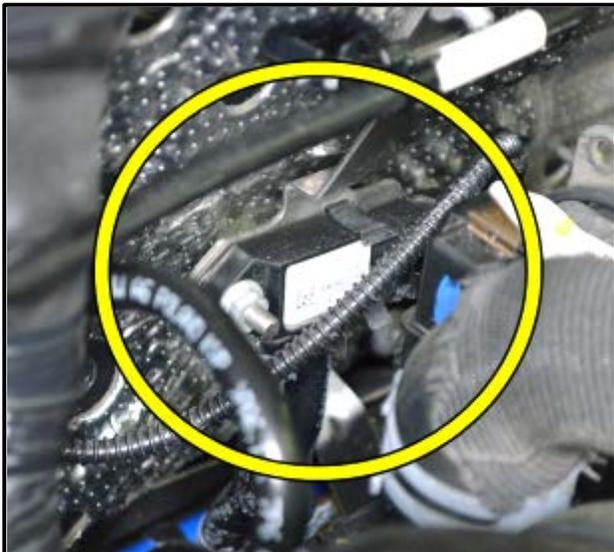
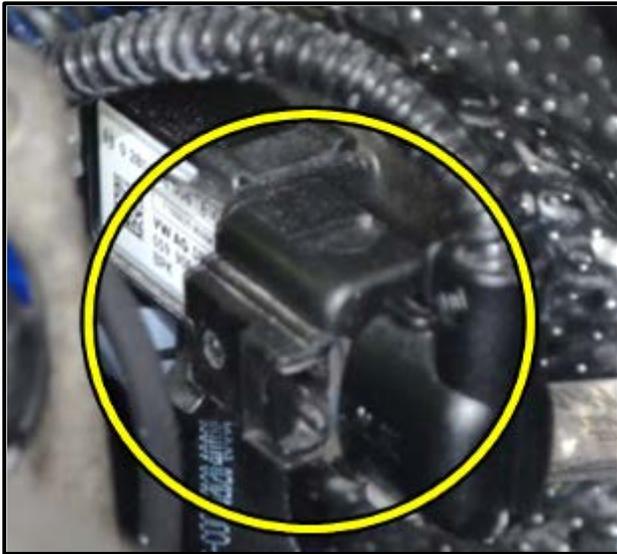
⇐ The differential pressure sensor is mounted in the center of the bulkhead, below the wiper cowl <circle>.

- Install the particulate filter hoses onto the new differential pressure sensor (P/N 059 906 051 A).
- Reposition the spring clamps.
- Install the new differential pressure sensor into the retaining clip.
- Install and torque the mounting nut to 3.5 Nm.

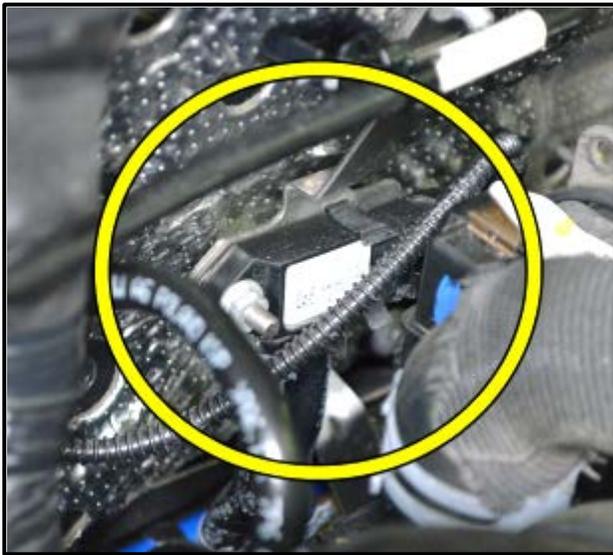
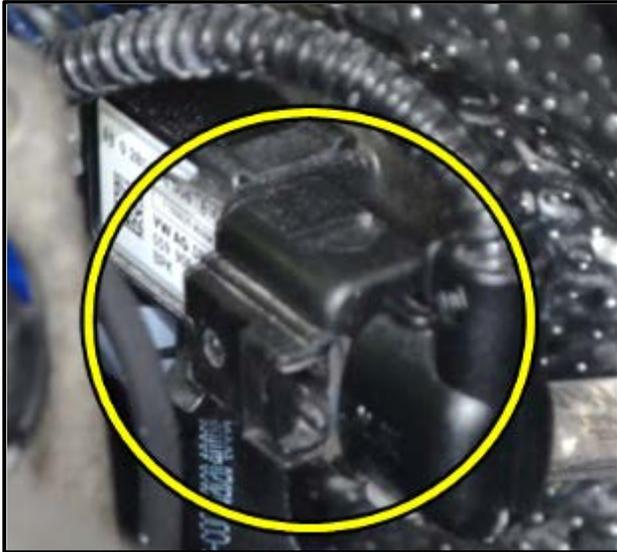
- Open the hood.
- Remove the engine cover.
- ⇐ The differential pressure sensor is mounted in the center of the bulkhead, underneath the wiper cowl <circle>.

- Install the new differential pressure sensor (P/N 059 906 051 A) into the retaining clip.
- Install and torque the mounting nut to 3.5 Nm.
