SB-10053937-8591

TECHNICAL BULLETIN

Service Action: Water Induced Misfire / Restricted Performance

AFFECTED VEHICLE RANGE:**Range Rover Evoque (LV)**

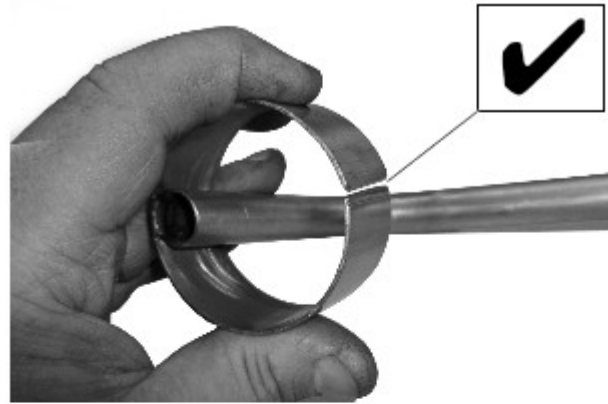
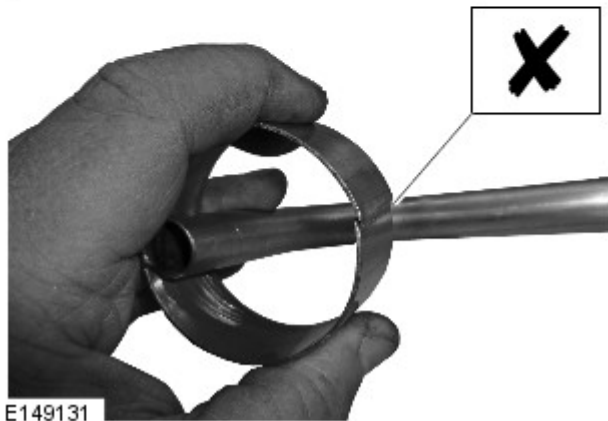
E149131

Note the acceptable deformation of the venturi ring prior to installation.

**CAUTION: The venturi ring will need to be slightly compressed during installation. Make sure that the ring is not compressed so that the ends of the ring overlap. Failure to follow this instruction may result in damage to the vehicle.**

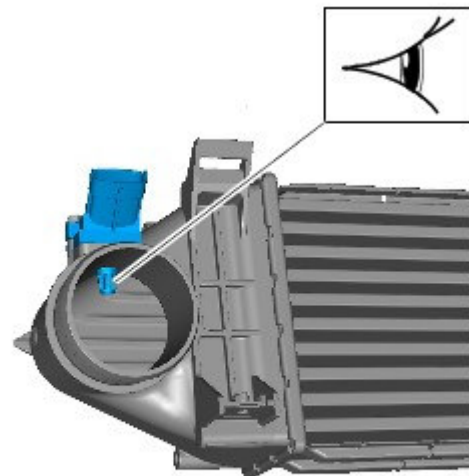
E149137

Note the position of the sensor.

**CAUTION: Make sure that the sensor is not damaged during the installation of the venturi.**
