SB-10053938-8589

DEALER SMM INFO FOR EPB DTC CODES C2007-11 AND C2008-11.

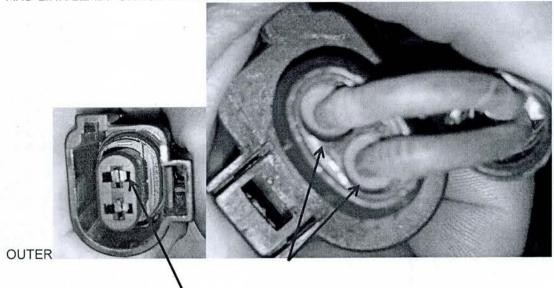
LINK LEAD SEALS – INNER AND OUTER. CHECK FOR PRESENCE AND DAMAGE.

4) CHECK THE LINK LEAD, CHECK THE PINS FOR CORROSION ON BOTH ACTUATOR AND LINK LEAD. CHECK THE SEALS ARE PRESENT BOTH INNER AND

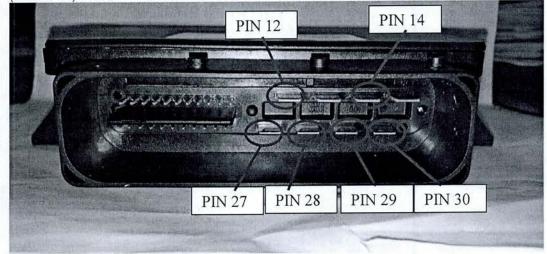
- 5) REMOVE LINK LEAD AND CAREFULLY CHECK FOR ANY VISIBLE SIGNS OF DAMAGE (CHAFING, PINCHING AND STRETCHING).
- 6) REMOVE EPB ECU (REFER TO TOPIX) AND TEST THE RESISTANCE BETWEEN THE MOTOR LINES AND GND ON THE ECU. USING PINS 12 OR 27 (MULTIMETER POSTIVE) TO PIN 28 (GND) FOR THE RIGHT CHANNEL (2007-11). USING PINS 14 OR 29 (MULTIMETER POSTIVE) TO PIN 30 (MULTIMETER G ND) FOR THE LEFT CHANNEL (C2008-11). THE RESISTANCE SHOULD BE 12.7 K OHM +/- 0.7 K OHM
