SUBJECT: **Regional Program 13R01**

Certain 2005 Through 2011 Model Year Crown Victoria, Grand Marquis, and Town Car Vehicles Not Covered Under Safety Recall 13S08
Steering Column Shaft

REF: **Safety Recall 13S08**

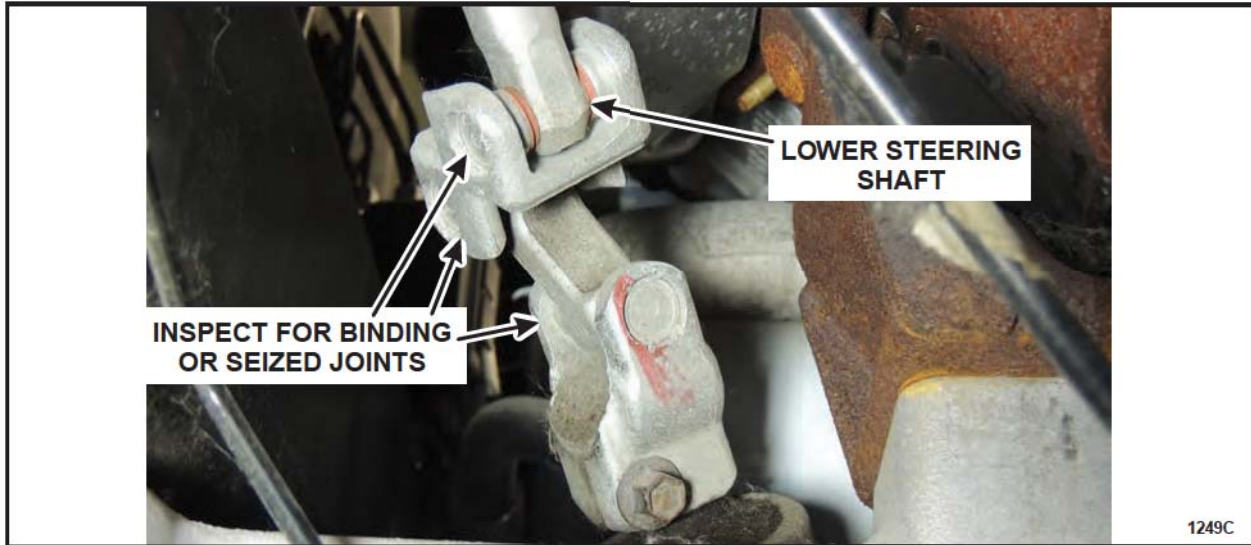
FIGURE 2

- c. Exercise the upper portion of the lower steering shaft throughout its range of motion. See Figure 2, on Page 2.
- d. If the lower steering shaft does not move freely and without binding, **it fails inspection.**

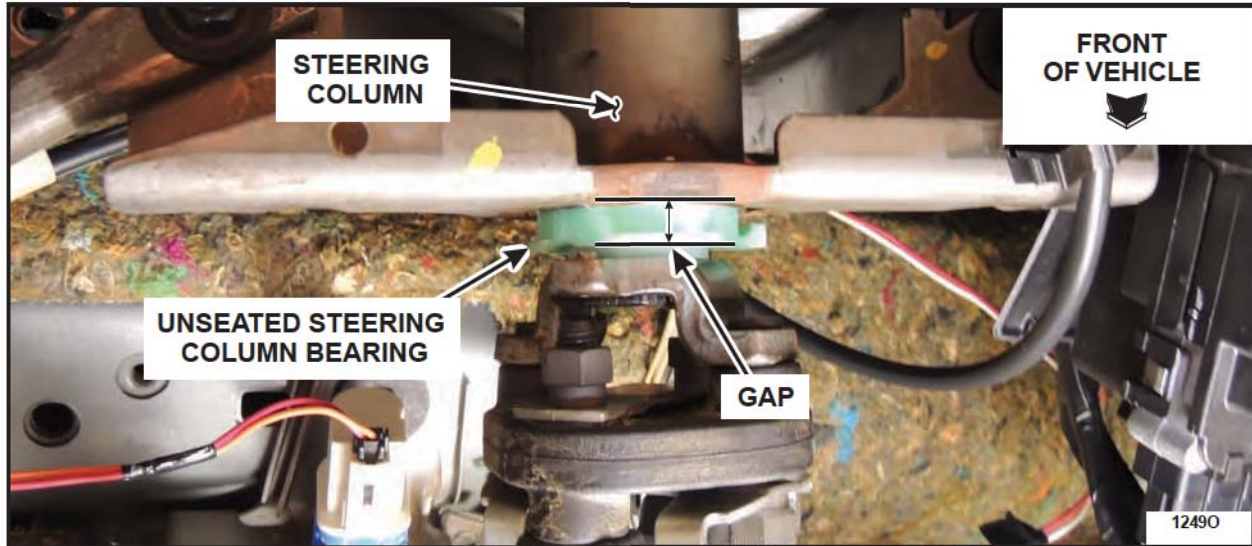
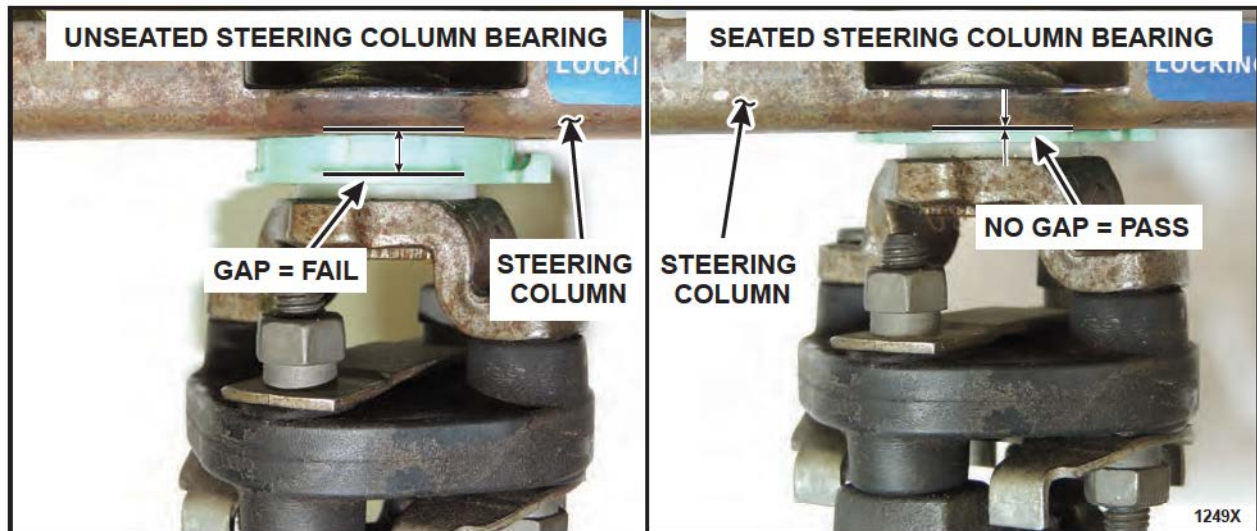
FIGURE 3

1. Inspect the steering column for an unseated steering column bearing. See Figures 3 and 4.

- If the steering column bearing is unseated, **it fails inspection**.

Steering Column Bearing Orientation and Retainer Installation (Failed Inspection Only, Refer to Flowchart within Attachment III)

2. Align the bearing alignment tab with the slot in the column flange. See Figure 8.

3. Use a suitable dead blow hammer to lightly tap the steering column to upper steering shaft coupling to seat the steering column bearing. See Figure 9.

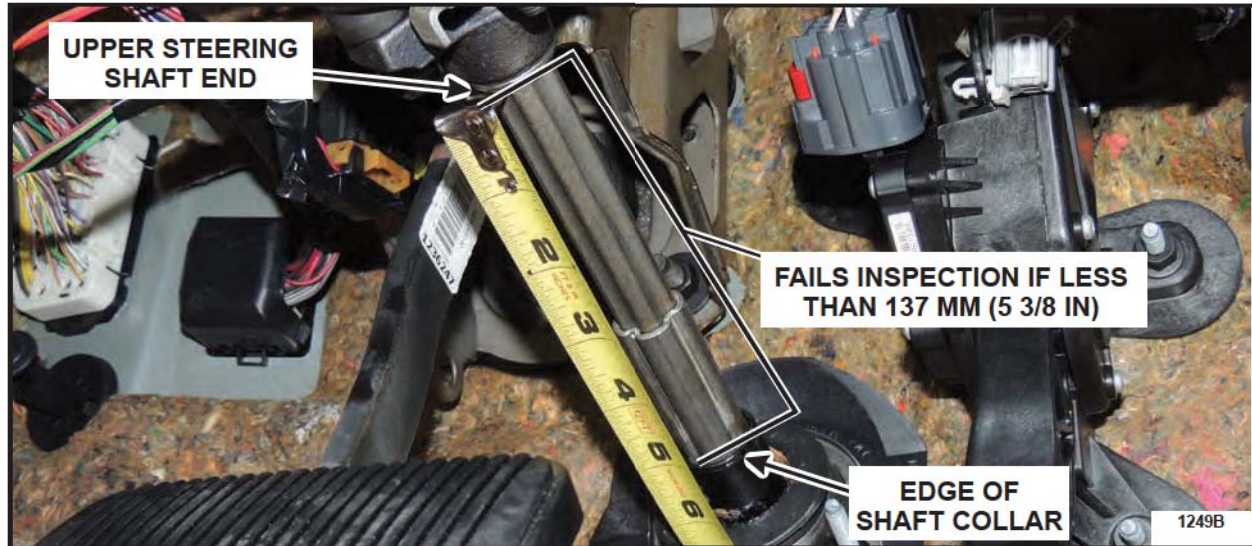
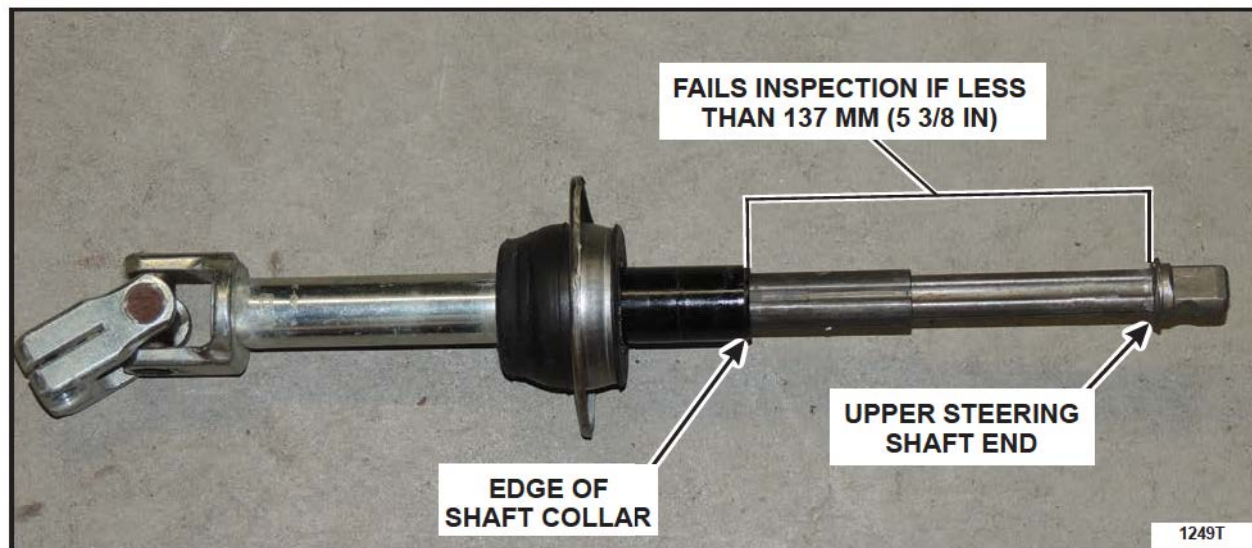
FIGURE 5

1. Measure the distance between upper steering shaft end and the edge of the shaft collar, to check for a collapsed upper steering shaft. See Figures 5 and 6.

- If the upper steering shaft measurement is less than 137 mm (5 3/8 in), **it fails inspection.**

7. Using a suitable punch and 16 ounce hammer, lightly tap around the steering shaft lip to evenly extend the shaft to 137-145 mm (5 3/8 - 5 3/4 in). See Figures 6 and 7.
 - Ensure that you tap around the entire steering shaft lip while performing this step to ensure that the steering shaft does not become misaligned within the shaft collar.
