Date 10.13 Group **356** No. **003** Release Page 1(5)

FSB 356-003, Fog Lamp Moisture Intrusion

(October 2013)

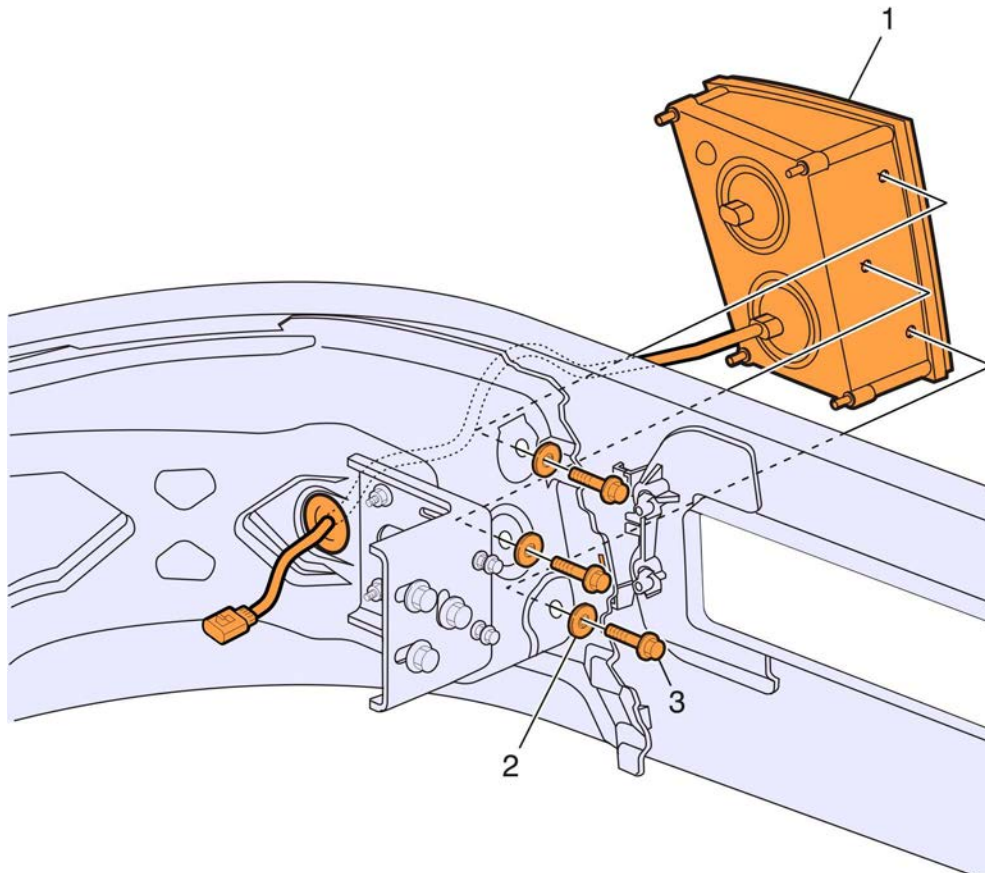
W3047653

It was determined that the use of pneumatic or high torque electric tools caused the captive nuts moulded into the fog lamp housing to spin and crack the housing. To prevent future failures, a new fog lamp installation procedure has been created. Should a fog lamp assembly require replacement, the new installation procedure must be used for the repair.

Note: Do not use pneumatic or high torque electric tools this may cause the captive nuts to spin and crack the fog lamp housing.

- 2 Using hand tool only, remove the three (3) mounting bolts.
