# Field Service Bulletin Trucks

## **SB-10054025-4212**

Oil Level Sensor Harness Wire Splice  
CHU, CXU, GU, LEU, MRU, TD

### **FSB 284-047, Oil Level Sensor Harness Wire Splice**

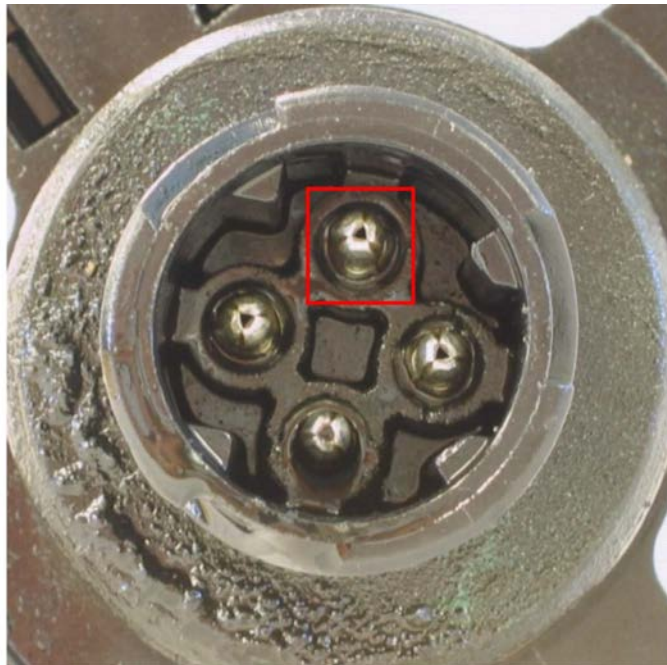
W2085817

Some MACK vehicles with MP engines built between January 2004 and September 19, 2013 may experience an oil level sensor failure that leads to oil contamination into the engine wire harness. A new anti-wicking pigtail splice kit, part number 85137983, is now available. Follow the procedure below if wicking is observed. Chassis with build date September 20, 2013 and later have the new solid pin connector and no action is required. The oil level sensor part number 21521353 with hollow pin type connector is now replaced with the new solid pin type connector oil level sensor part number 22022794. The new solid pin connector does not allow oil to wick into the engine harness.

Old Style Hollow Pin Connector

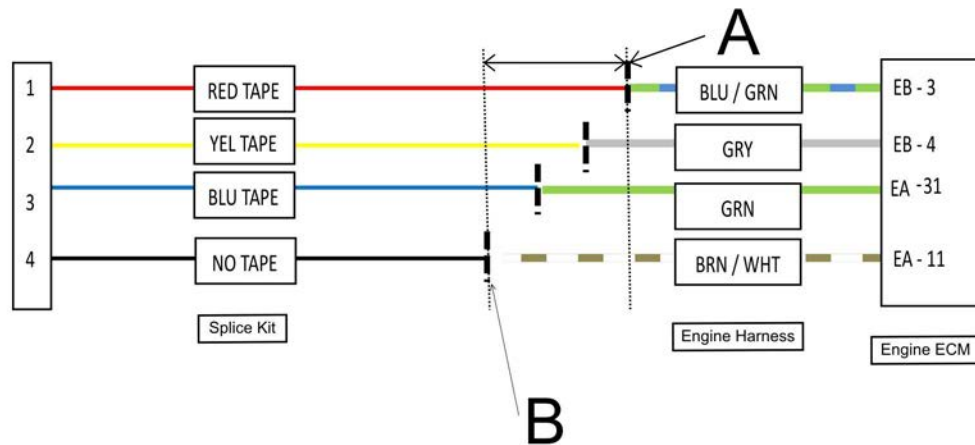
W3085820

A.	Length of cut harness plus 75 mm (3 in) to allow the splice stagger
B.	Length of initial harness cut

10 Stretch the wires together and clip one wire from the splice kit to the same length as the wires on the contaminated harness. Cut the rest of the wires in the splice kit in a staggered pattern at increasing lengths. The length from the shortest wire to the longest wire should be approximately 75 mm (3 in). Install the previously removed loom over the splice kit connector.
